**Carrie Furnace Site Redevelopment  
Phase II**

**Carrie Furnace Facilities**

**Re-Inspection and Revision Report  
April 2009**

**Wilbur Smith Associates**

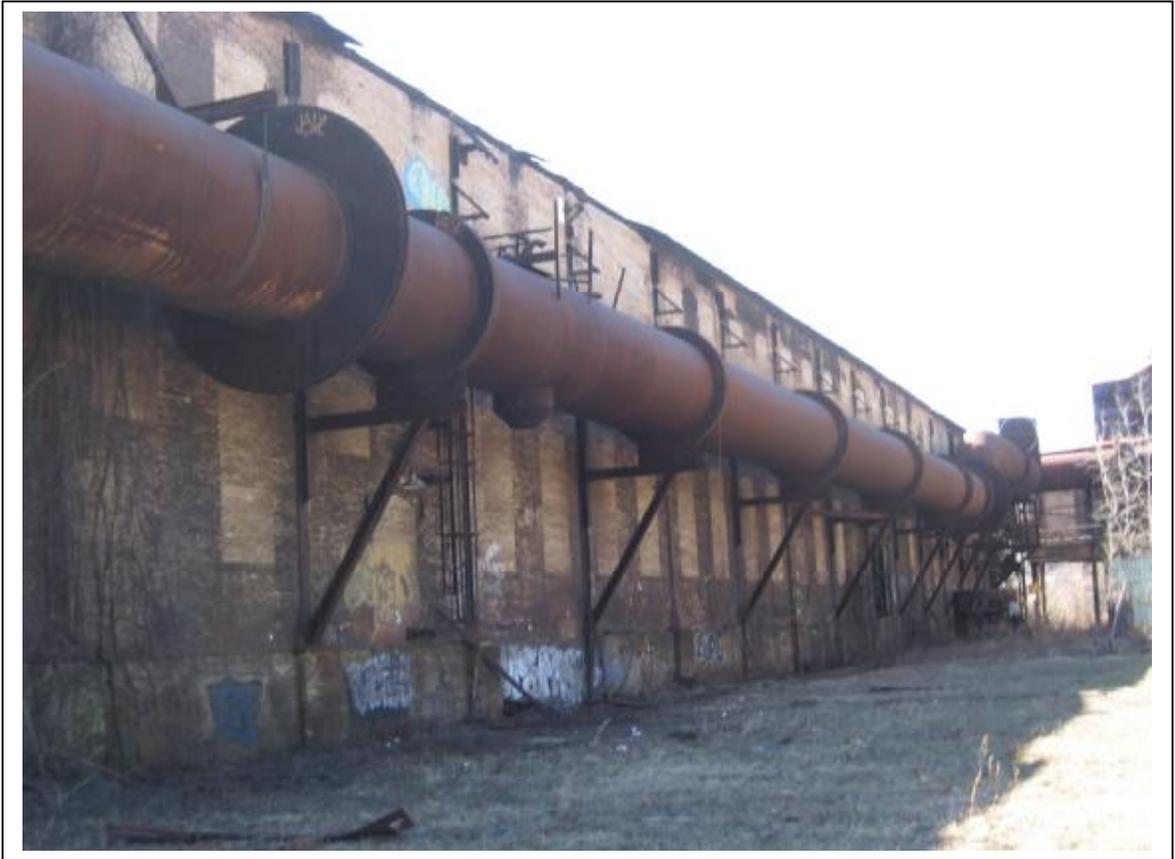
Building #1 is a large warehouse type structure with a steel truss roof system and a 50 Ton crane that runs the length of the building (See Photo 1). Several of the building elements have problem areas in poor condition. The roof, made up of timber planks and metal decking, is in imminent failure condition with large areas of missing and deteriorating planks (See Photos 2, 3 and 4). The wooden planks are rotten and a majority of them are missing or are in pieces inside the building on the floor. The metal roof decking has large areas missing and is present around the exterior perimeter of the building on the ground. The roof wooden planks and metal decking are in a failed condition, meaning that they are beyond repair.

Photo 1: Building #1 exterior

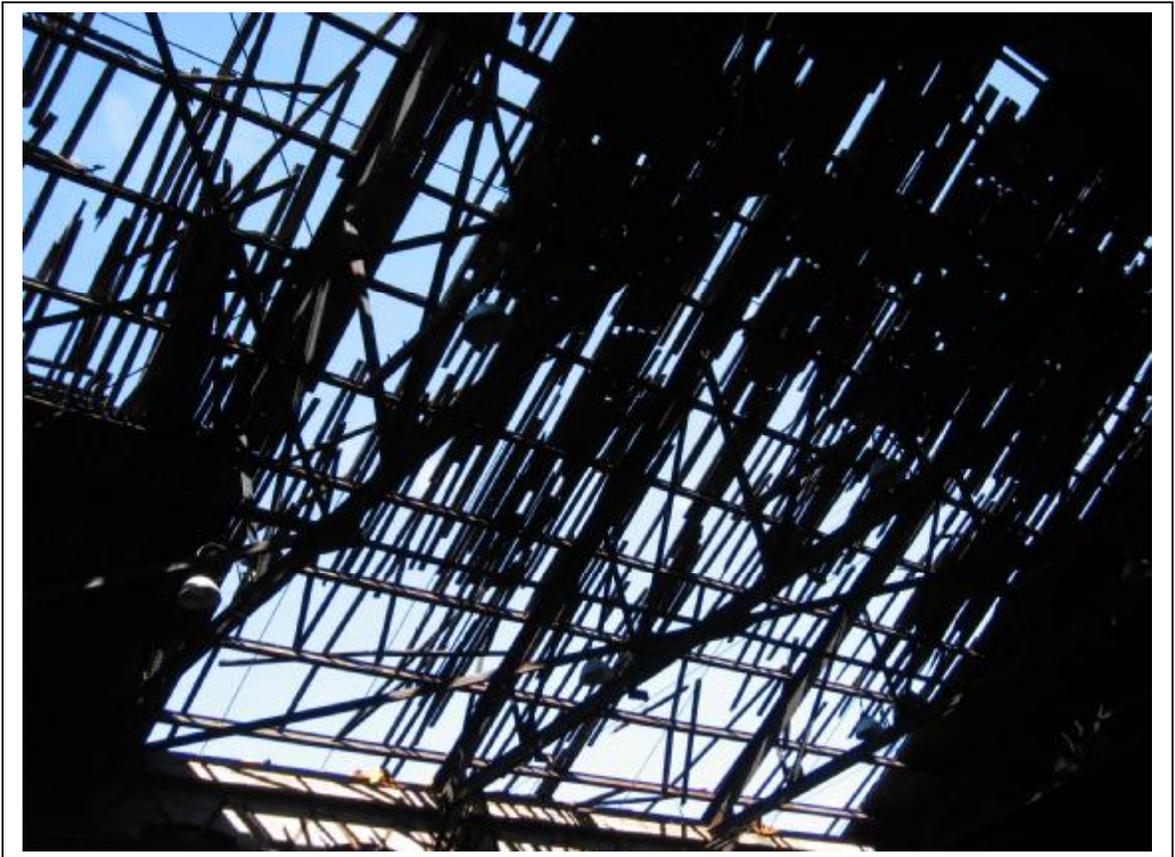
Photo 2: Building #1 Roof with missing and deteriorated roof

The roof is a hazard and needs corrective action for safety and to help preserve the Building.

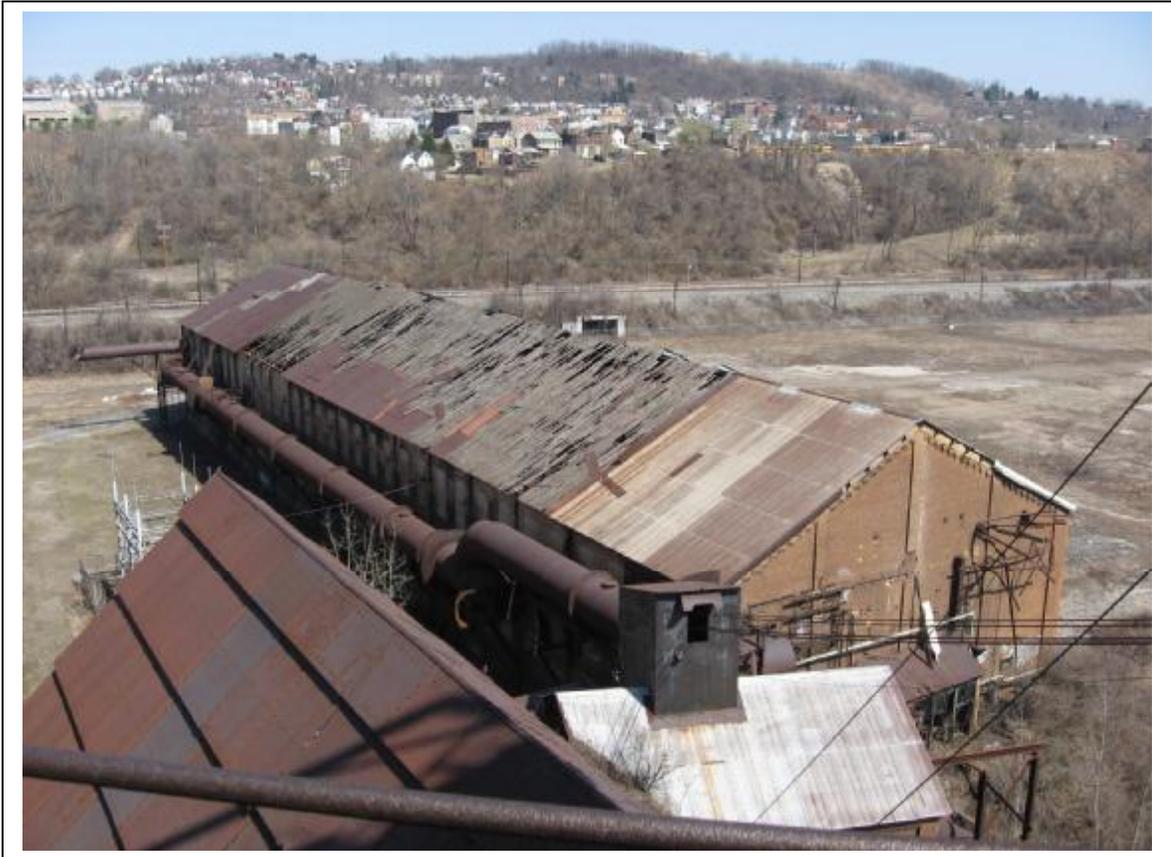
Photo 3: Building #1 Roof

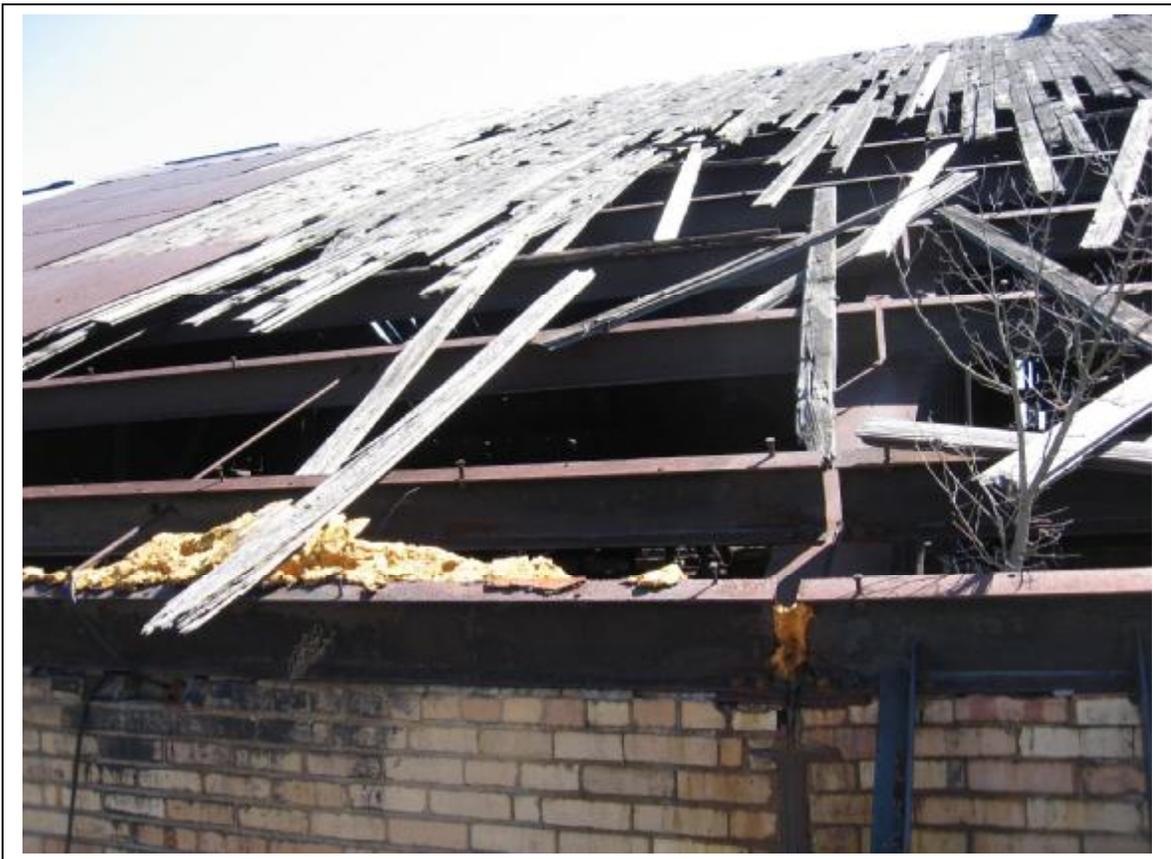
Photo 4: Building #1 with missing and deteriorated roof

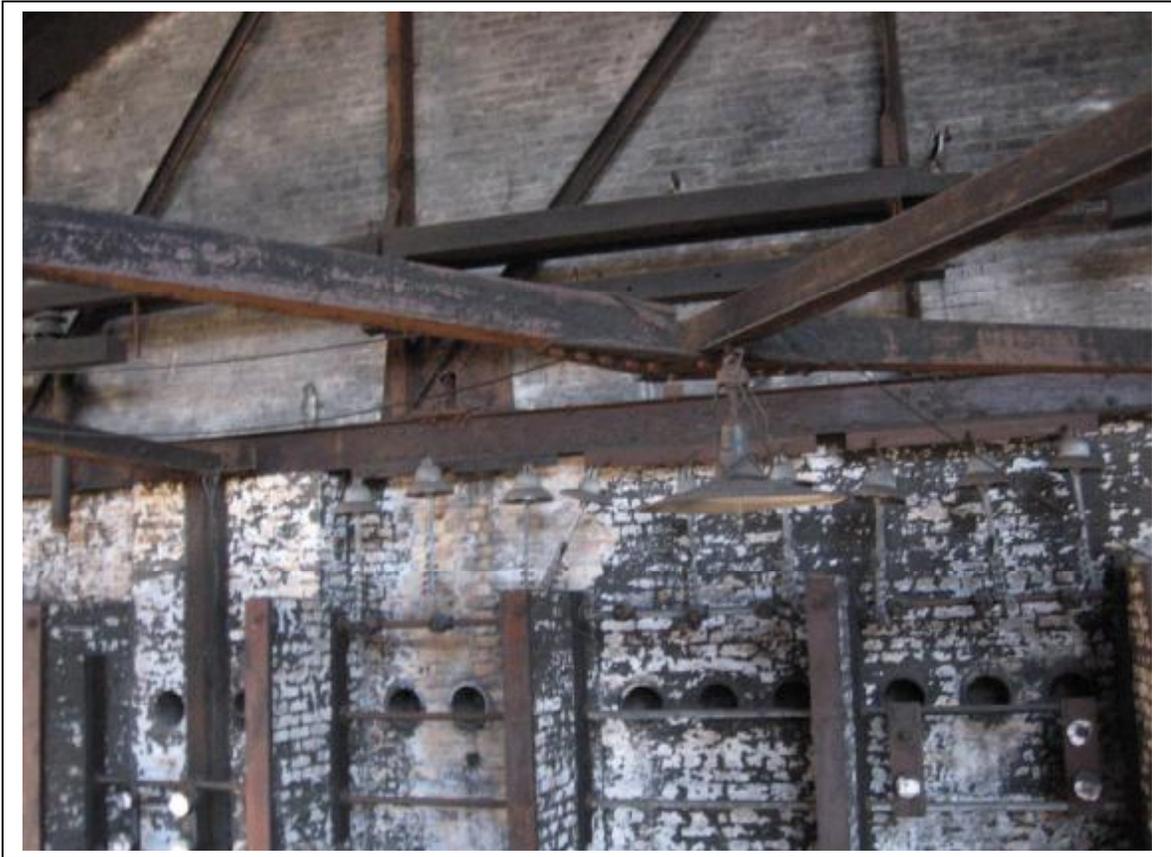
The roof support system, made up of steel roof trusses and I shaped purlins, is in good condition (See Photo 6) with isolated areas with missing lateral bracing on the western end of the structure, between column lines 17 and 18 (See Photo 5). Above the crane between column lines 1 and 2, near the north side of the building, a roof truss lateral bracing is not connected and is loose on one end.

Photo 5: Building #1 missing roof truss lateral bracing

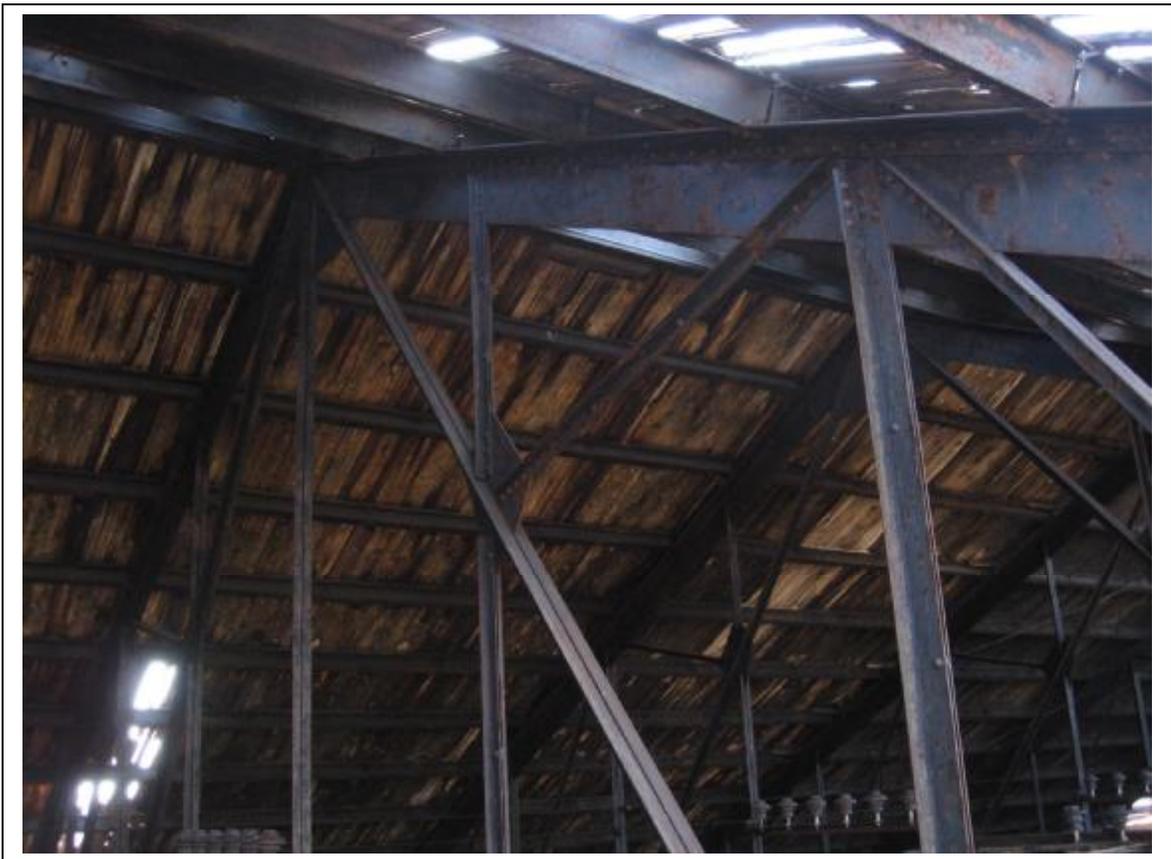
Photo 6: Building #1 Typical roof truss condition

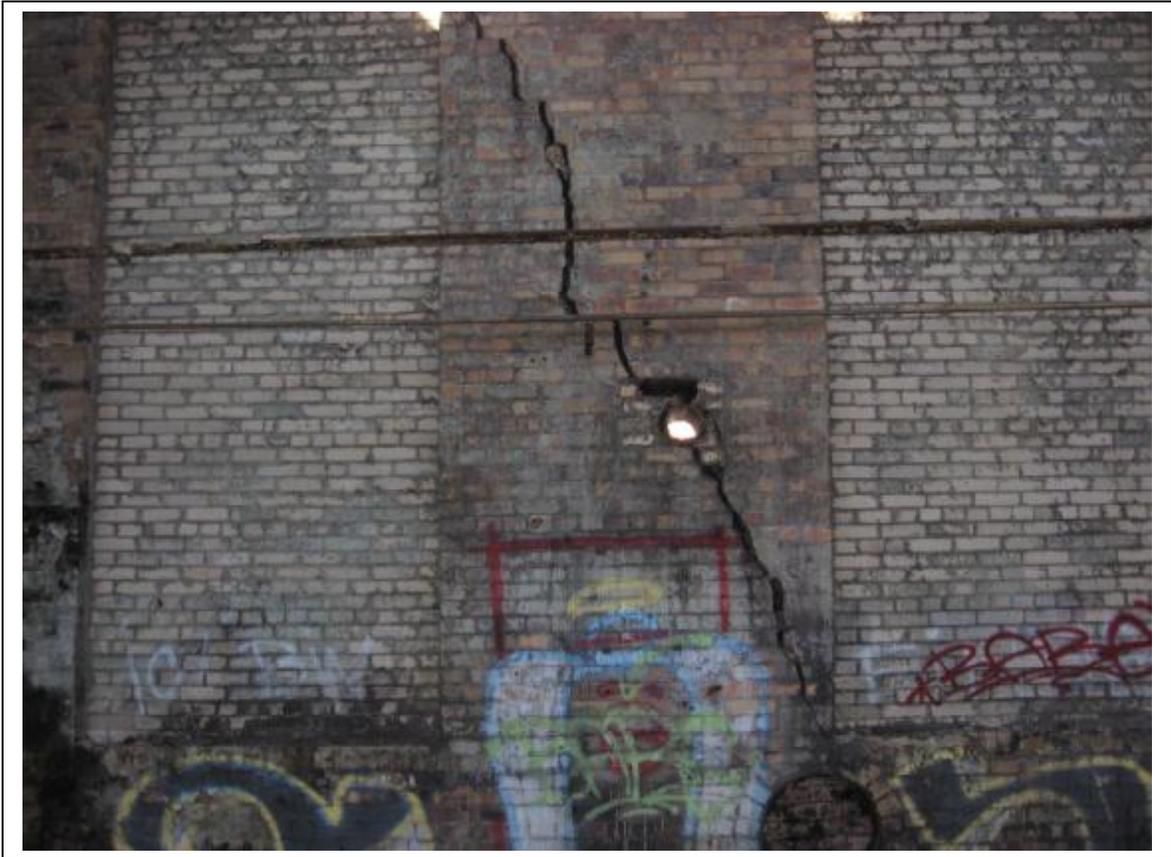
The north wall has several large diagonal cracks up to 2 ½" wide from between corners of the old window openings. These exist between column lines 13-14 and 14-15 (See Photo 7). A large hole, approximately 6-ft wide by 10-ft high, had been broken through the north wall between column lines 15-16. The east wall has diagonal cracks underneath old window openings.

Photo 7: Building #1 Crack through north wall between column lines 14-15

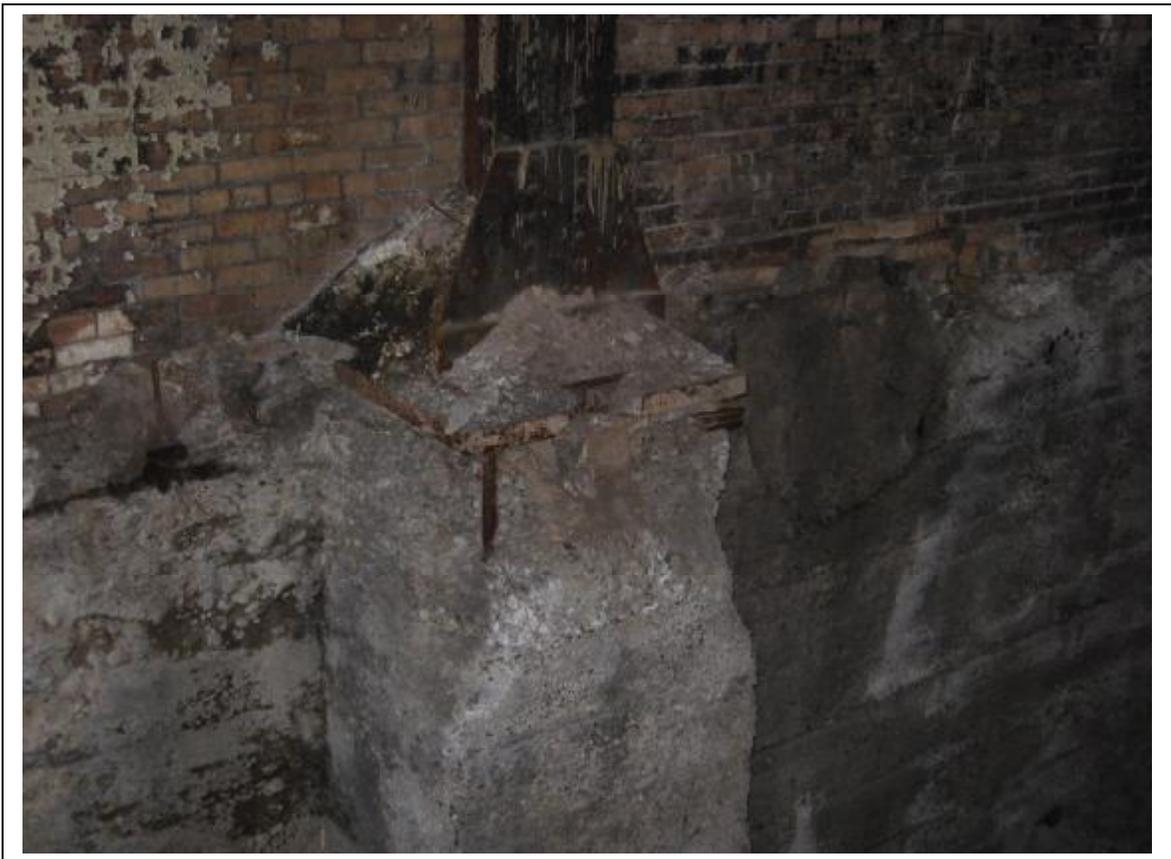
Photo 8: Building #1 Column 17-B, exposed anchor bolts and undermined base plate

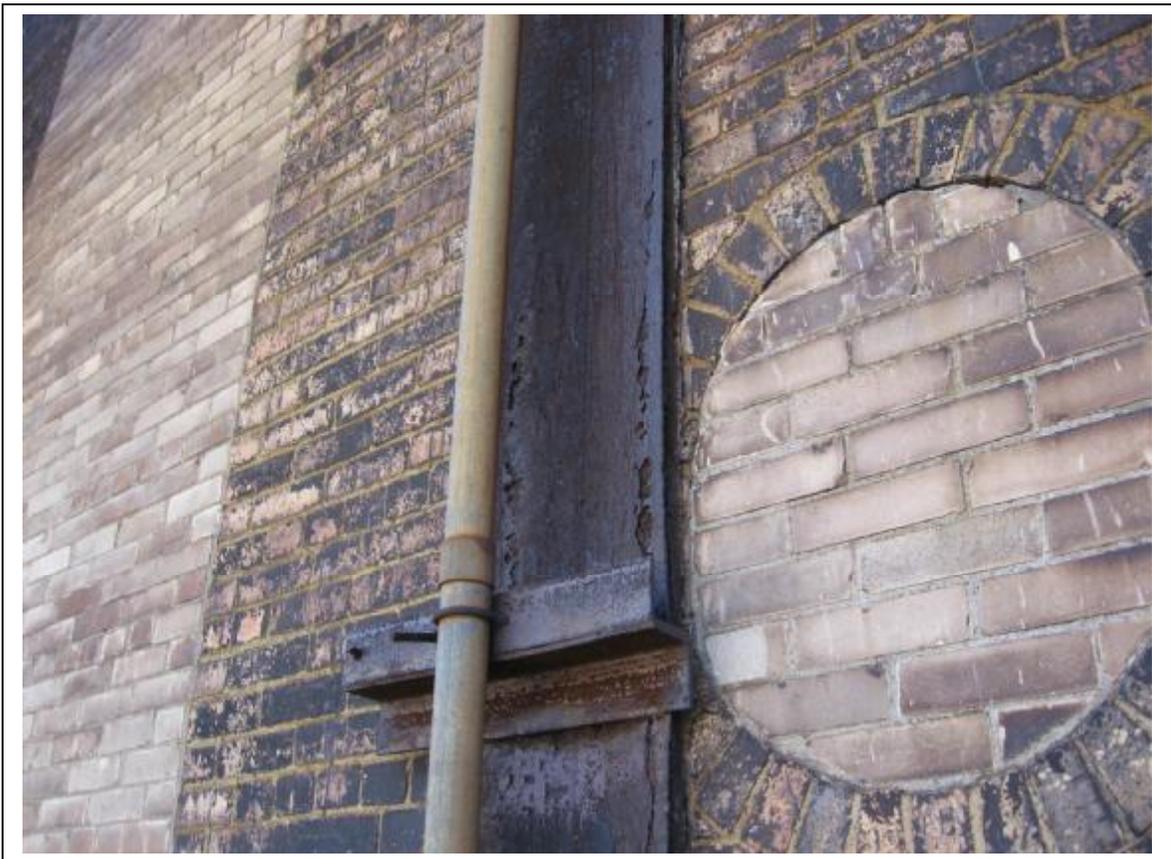
Photo 10: Building #1 Typical condition of exterior column face with section loss to exposed flange

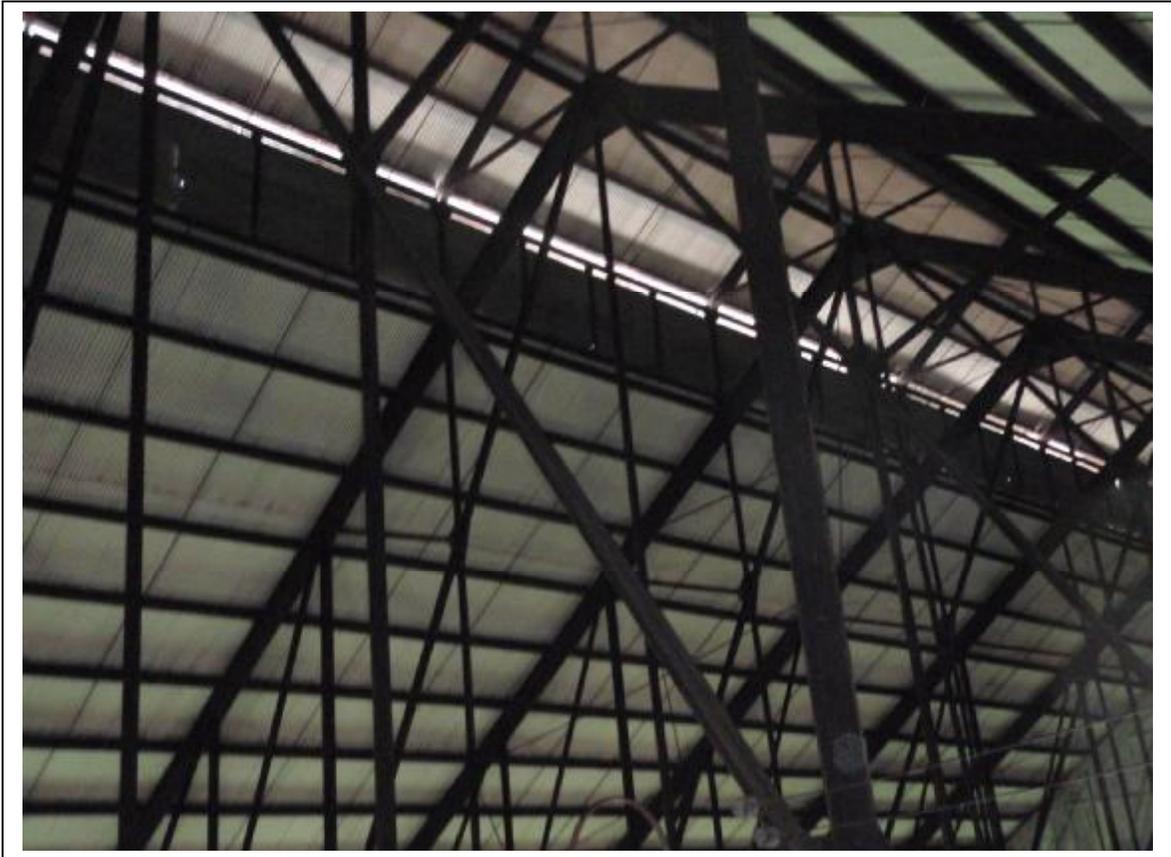
Building #2 (See Photos 17 and 18) is a large warehouse type structure with a steel truss roof system and a 50 Ton crane that runs the length of the building. The roof system is in relatively good condition with some lateral bracing elements missing (See Photos 11 and 12). These include bracing between the roof trusses along columns lines:

Photo 11: Building #2 Typical roof system

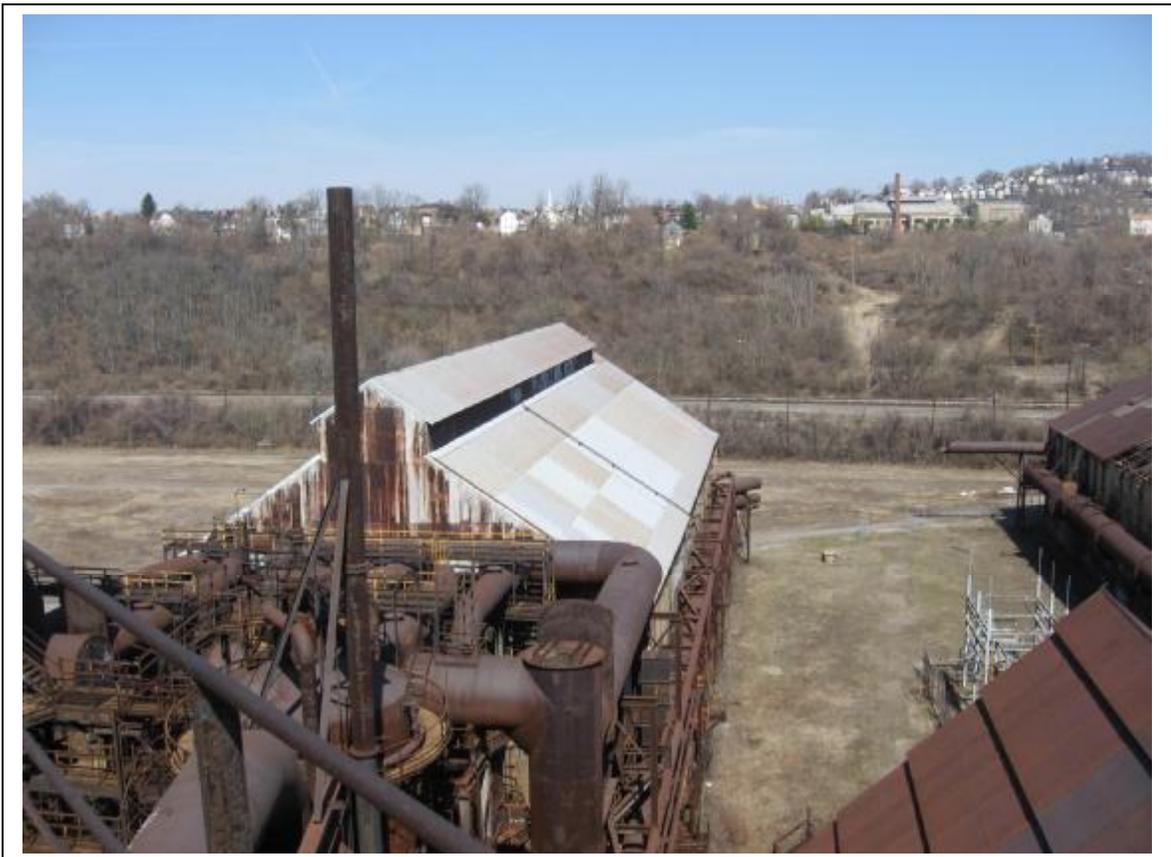
Photo 12: Building #2 Roof

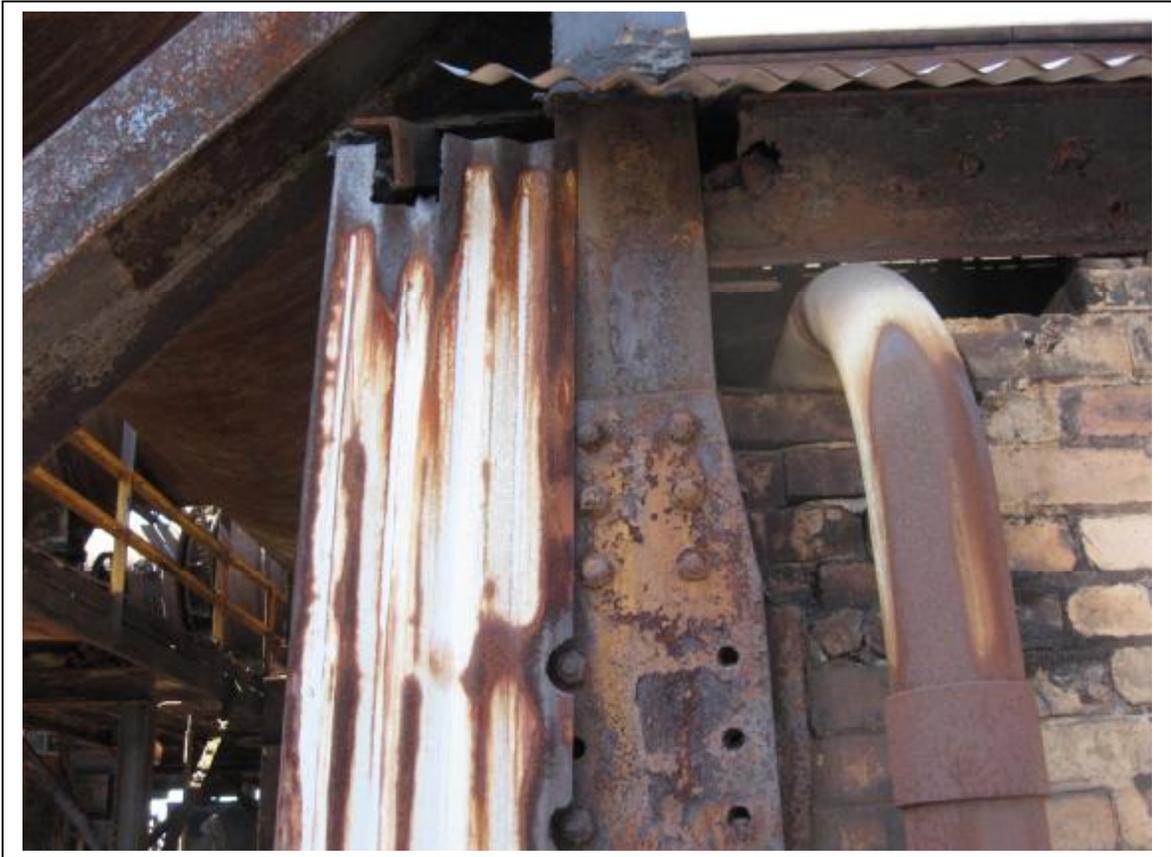
Photo 13: Building #2 Column 12-A near top, four missing rivets

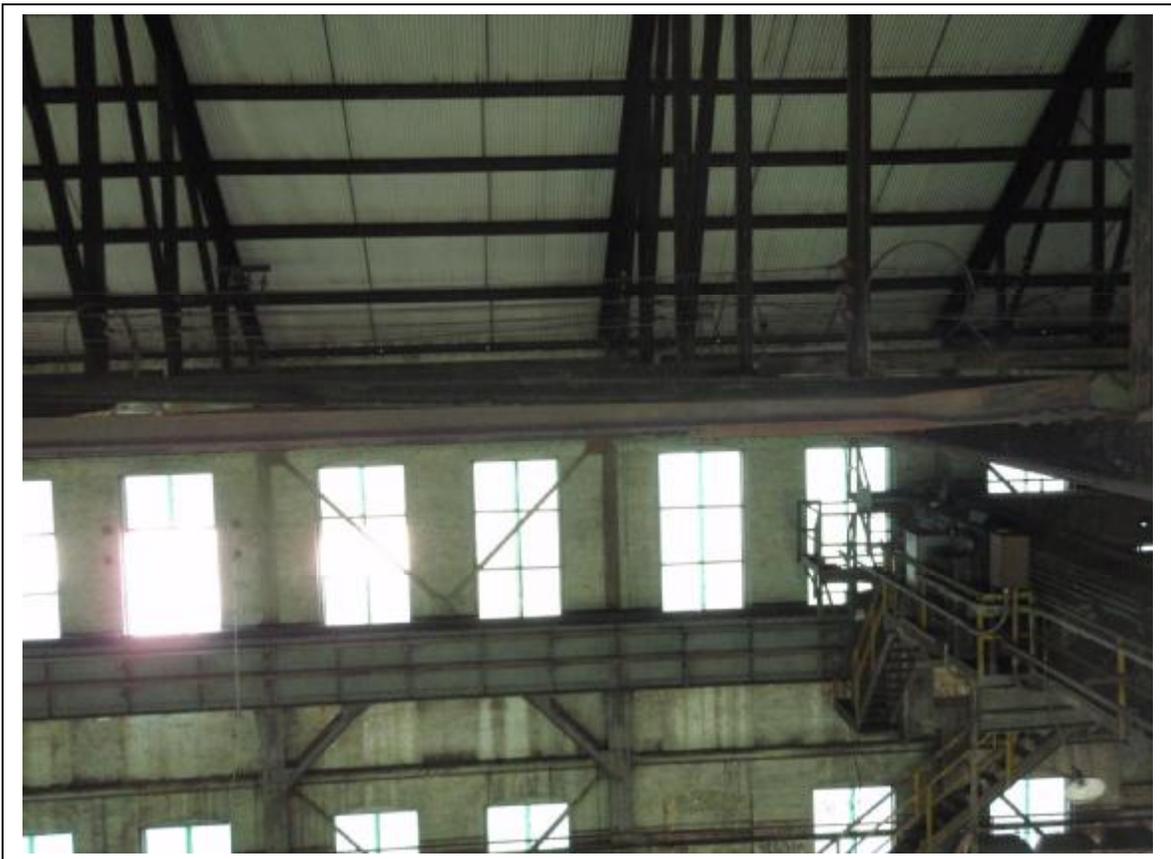
A roof truss lateral bracing between column 1-2 and E-F is not riveted and is loose. One lateral bracing is twisted between column lines 3-4 and C-D (See Photo 14).

Photo 14: Building #2 twisted lateral bracing of roof truss between columns 3-4 and C-D

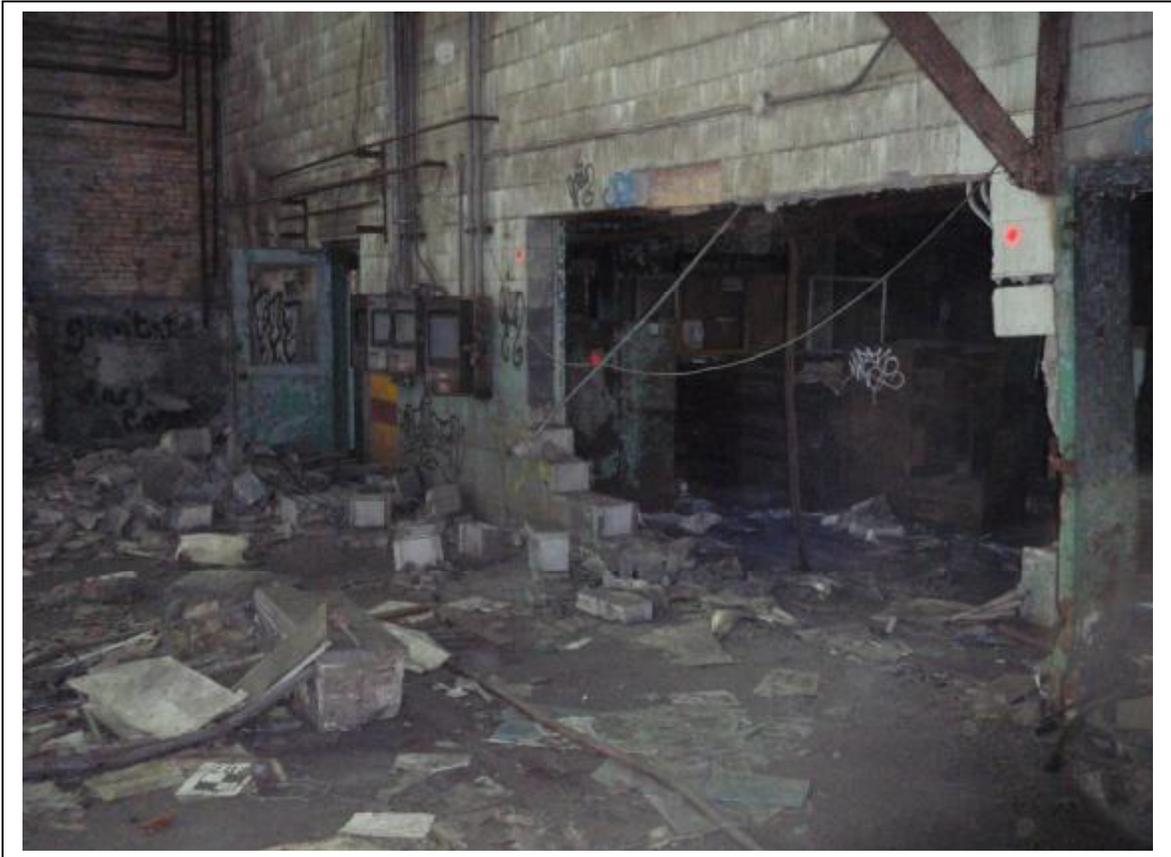
The western end of the building houses an office area which is in poor condition. A portion of the front wall of the office area has been partially demolished leaving the remainder of the wall in danger of collapse (See Photo 15). At the upper level of this office space areas of the roof have partially collapsed (See Photo 16). This area is in imminent failure condition and needs to be completely demolished.

Photo 15: Building #2 Partial demolished office space – “Imminent” failure condition

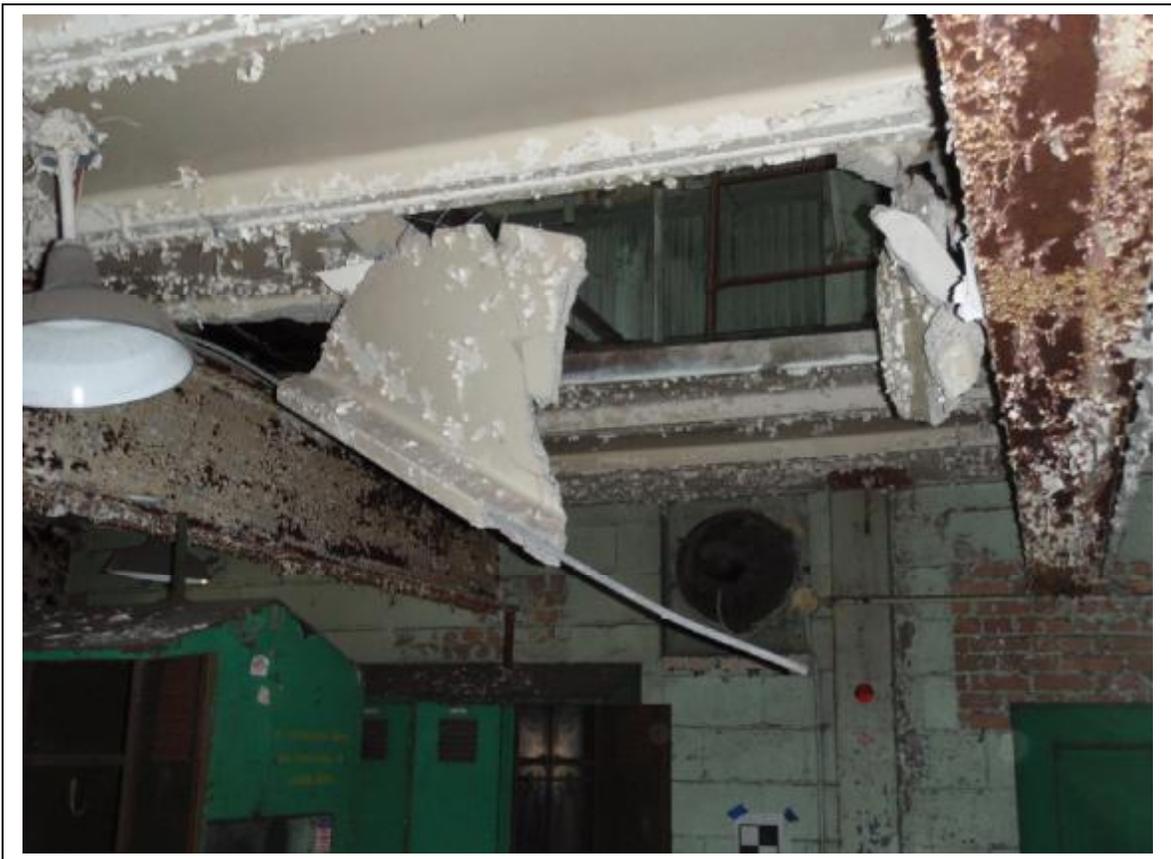
Photo 16: Building #2 Upper floor of office space with roof partially collapsed – “Imminent” failure condition

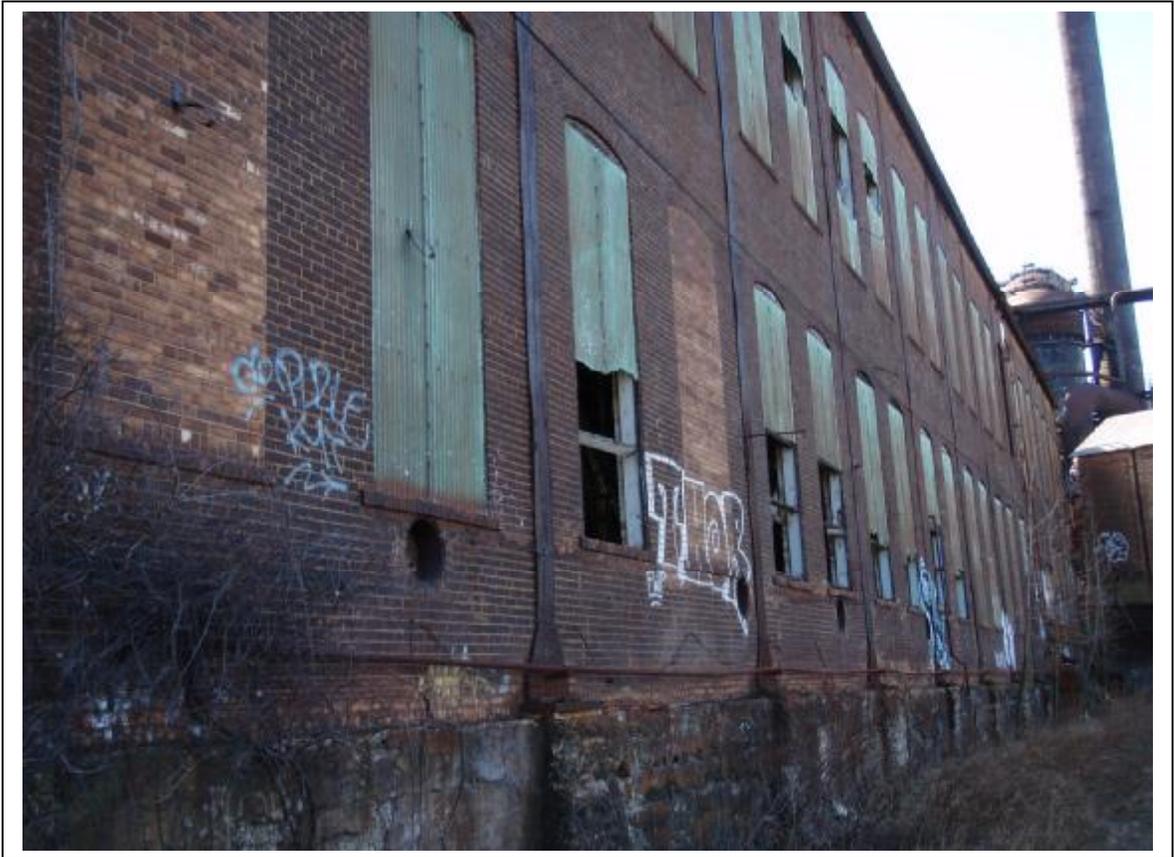
Photo 17: Building #2 Exterior north wall typical condition

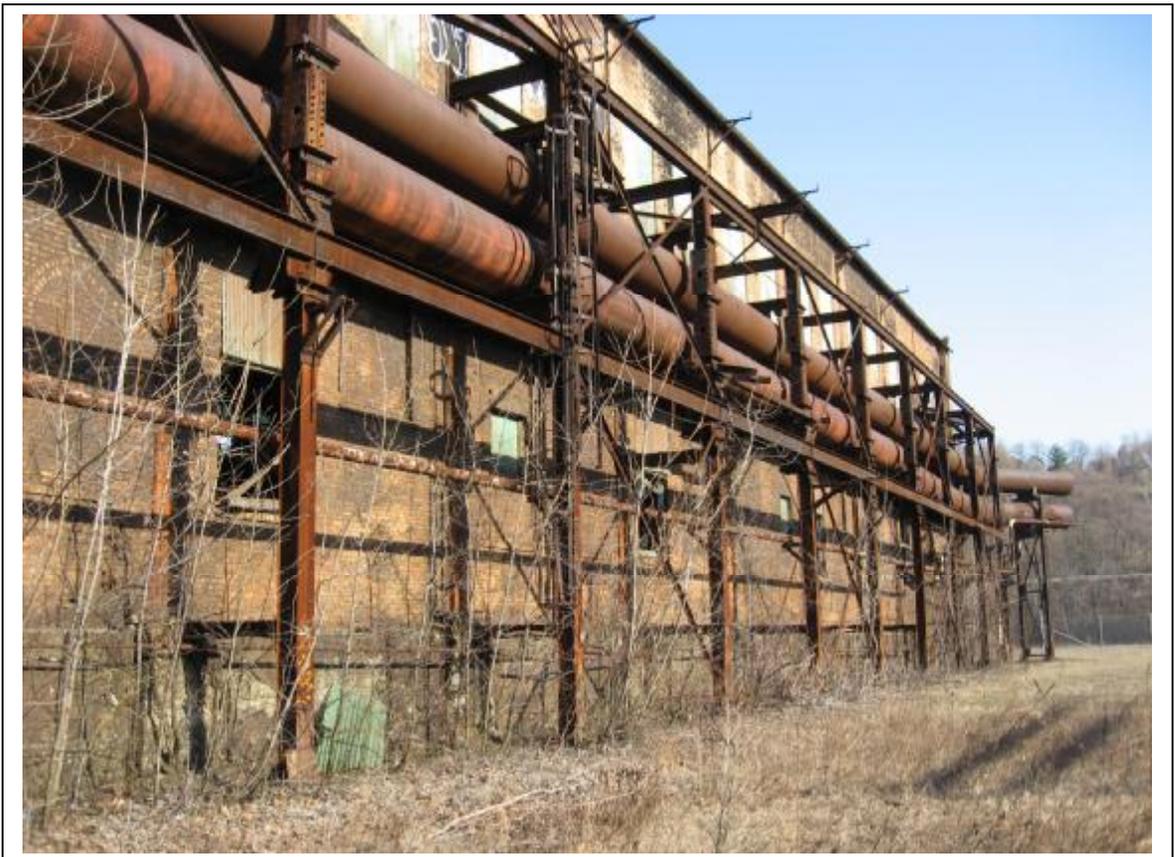
The pipe support towers, which run along the exterior of the south wall of Building #2, have major deterioration of the lateral members near the bottom of the towers (See Photo 18). These members tie the towers into the base of the building columns. The webs of the members have 100% section loss at numerous locations and the bottom flanges have 70% section loss. Some members near the top of the pipe support frames near columns 6, 7, 9 and 10 (See Photos 19-24). These members should be repaired to insure the stability of the towers.

Photo 18: Building #2 Exterior south wall with pipe supports

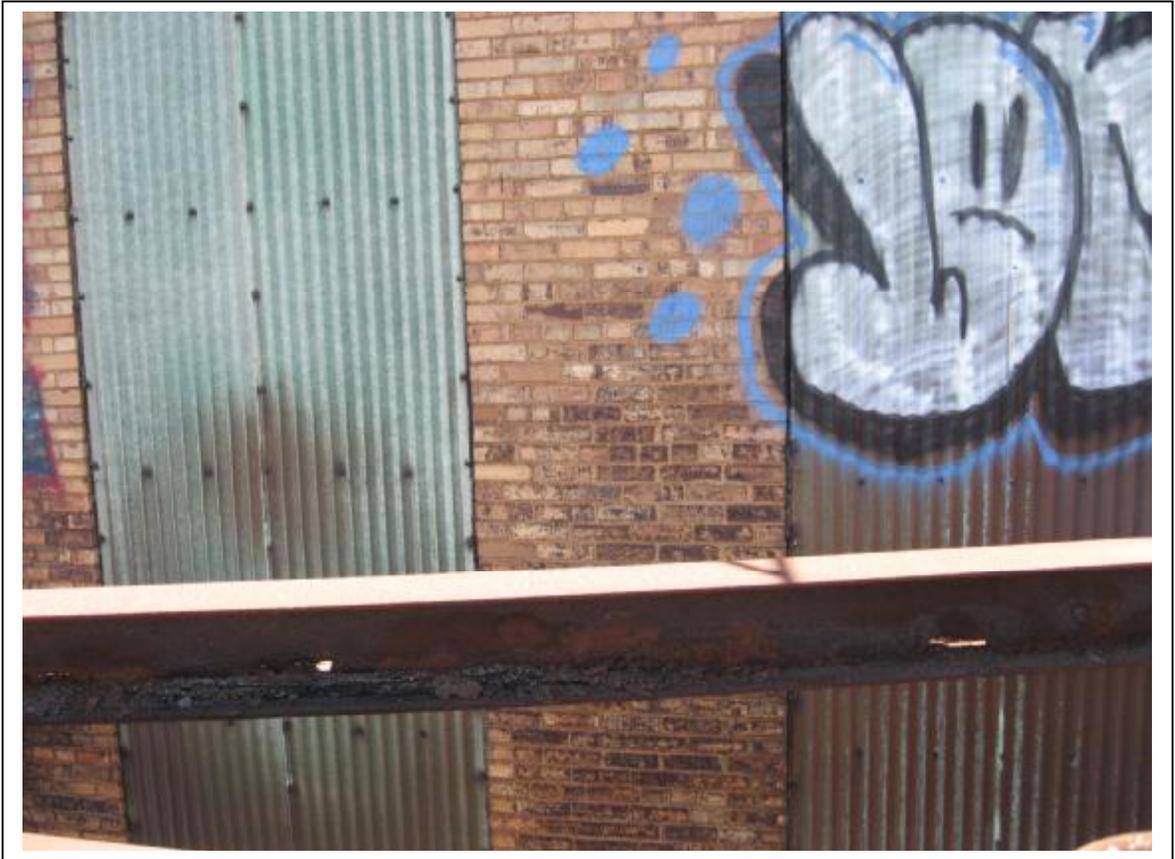
Photo 19: Exterior of Building #2 pipe support member with section loss

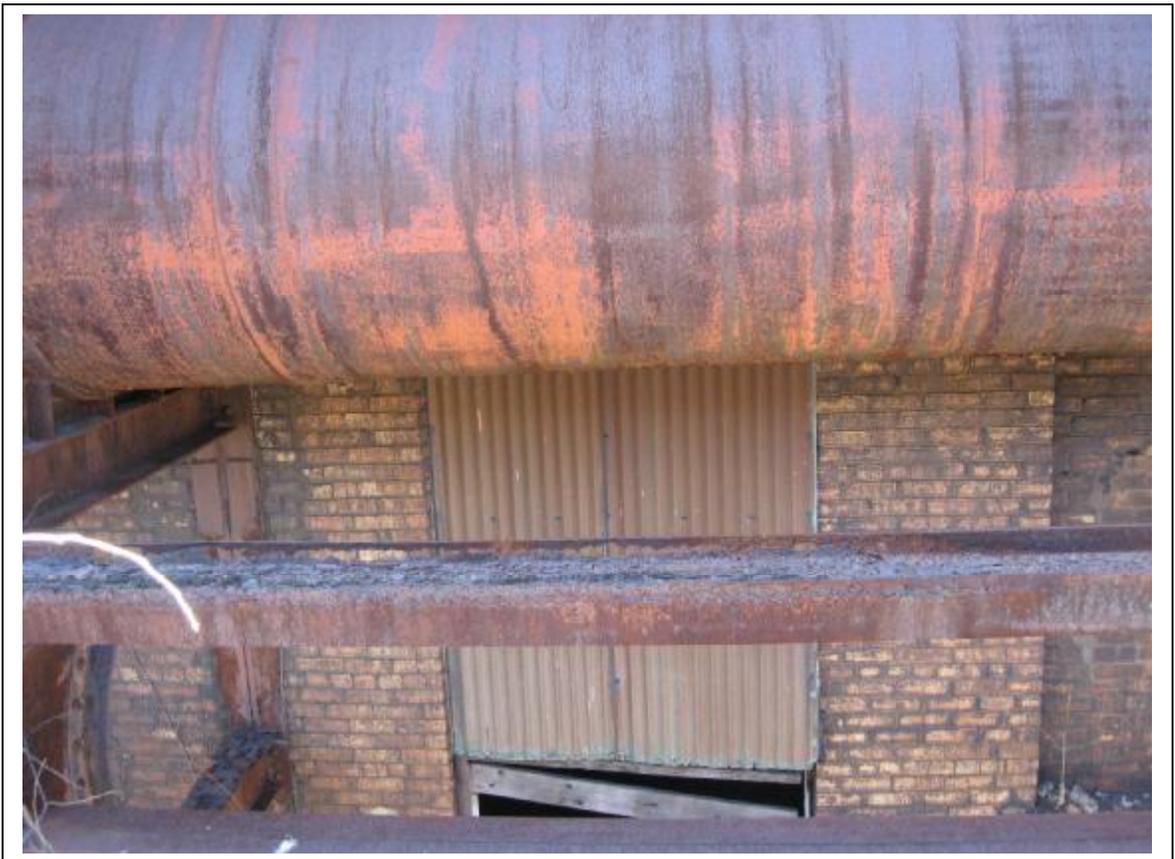
Photo 20: Exterior of Building #2 pipe support with section loss

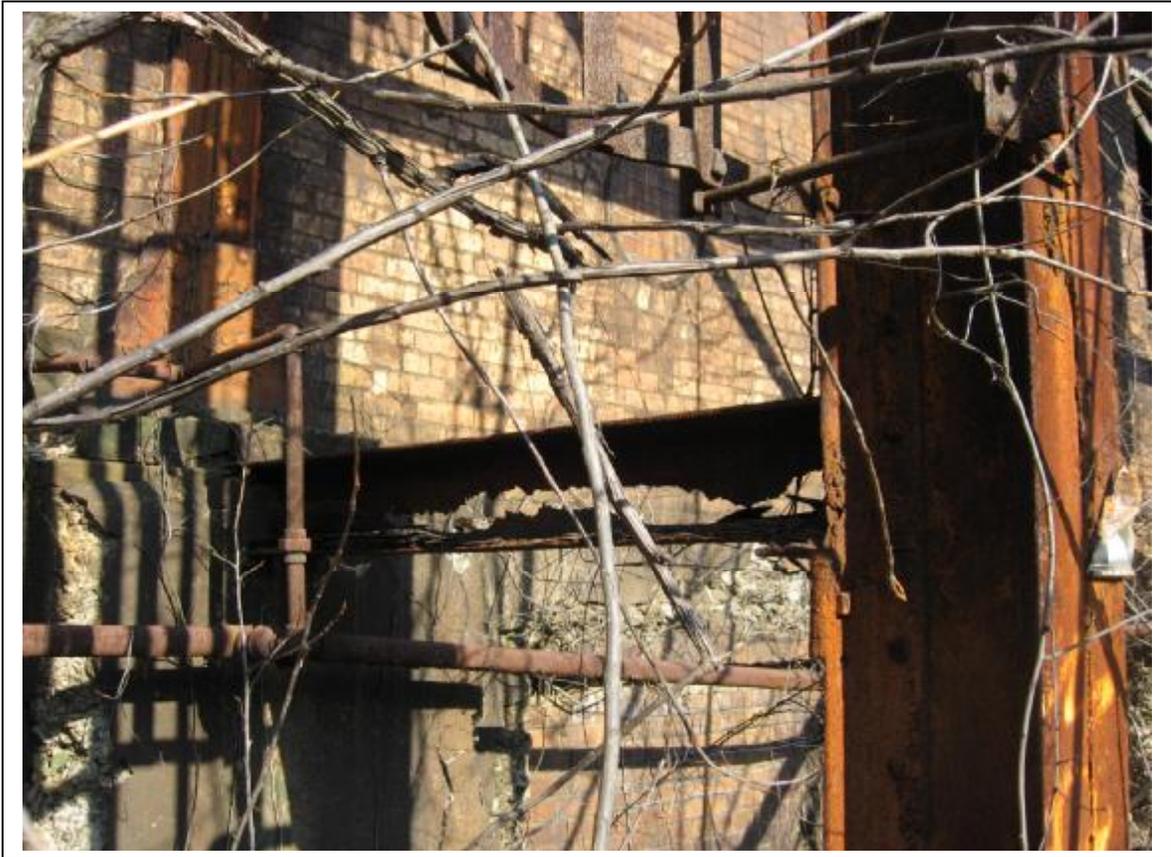
Photo 21: Exterior of Building #2 pipe support member with section loss

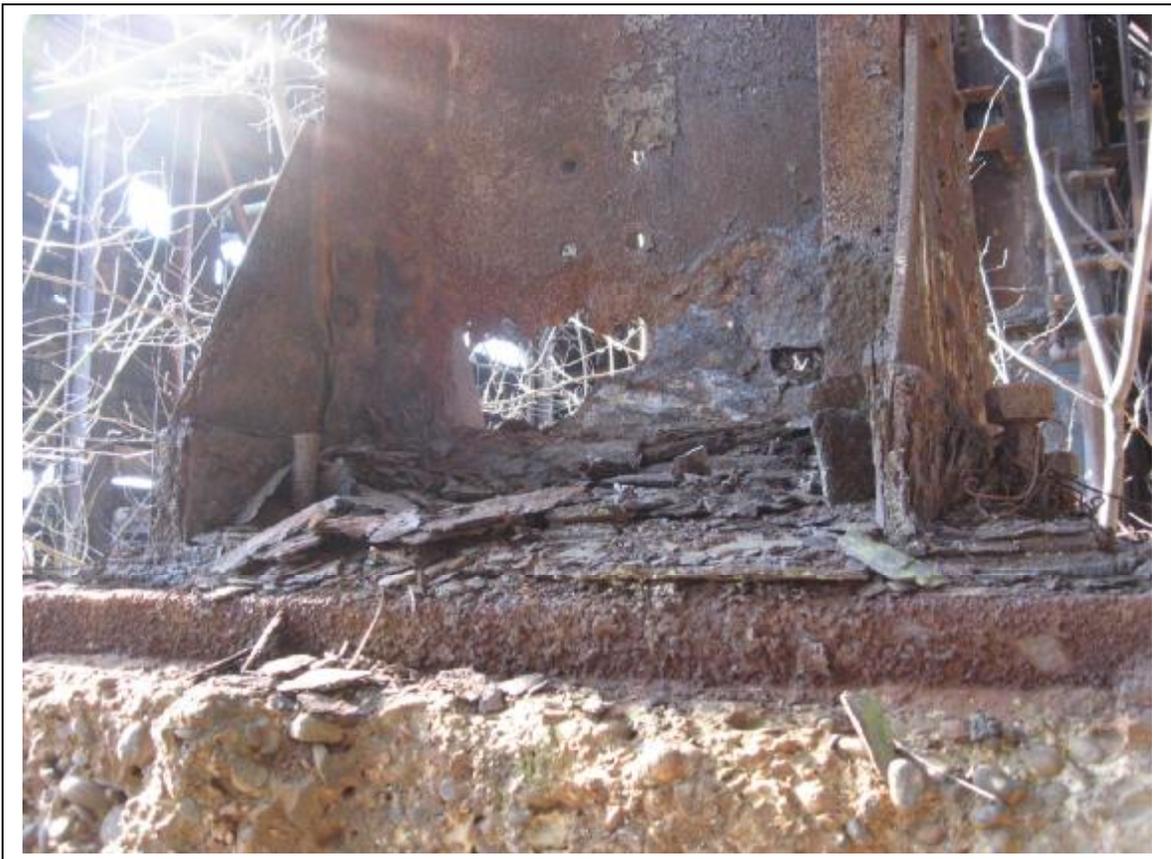
Photo 22: Exterior of Building #2 pipe support member with section loss
