**Carrie Furnace Site Redevelopment  
Phase II**

**Carrie Furnace Facilities**

**Re-Inspection and Revision Report  
April 2009**

**Wilbur Smith Associates**

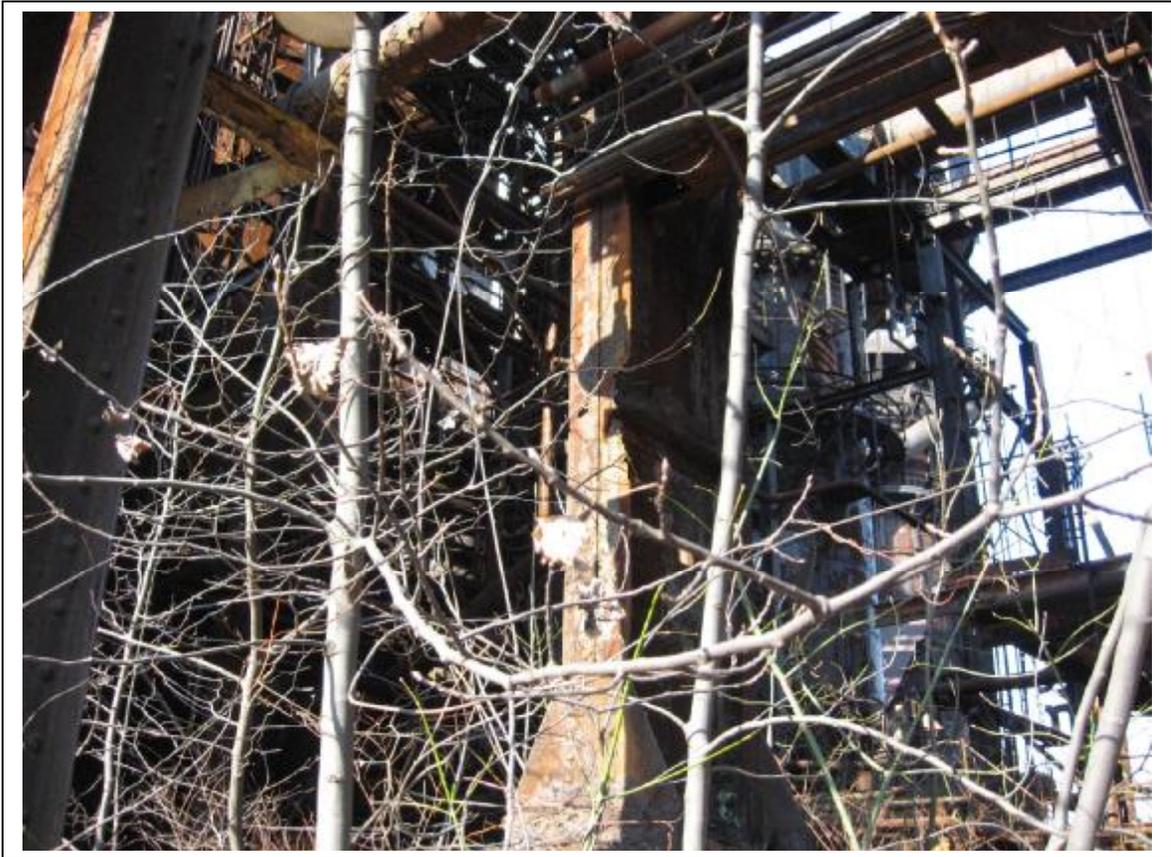
Photo 23: Exterior of Building #2 pipe support member with section loss (roughly 10-ft above ground)

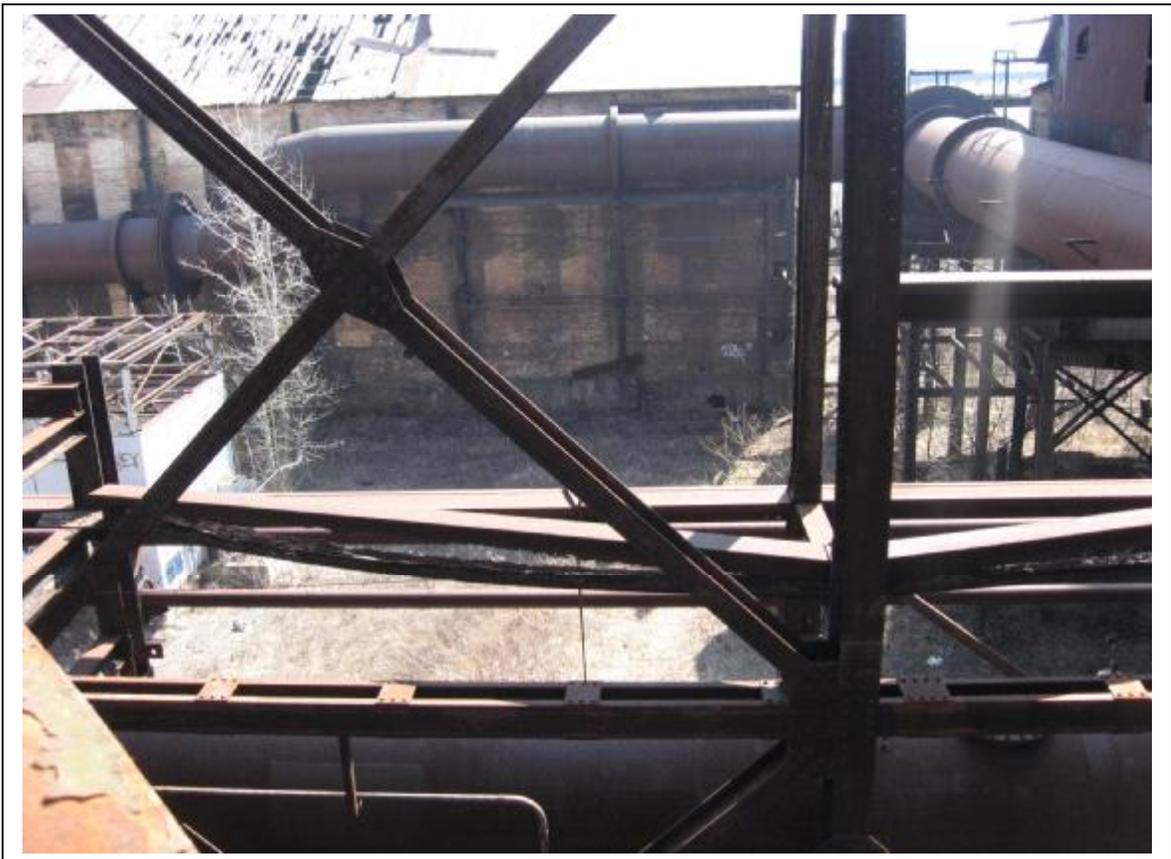
Photo 24: Exterior of Building #2 pipe support lateral bracing member with 100% section loss to webs

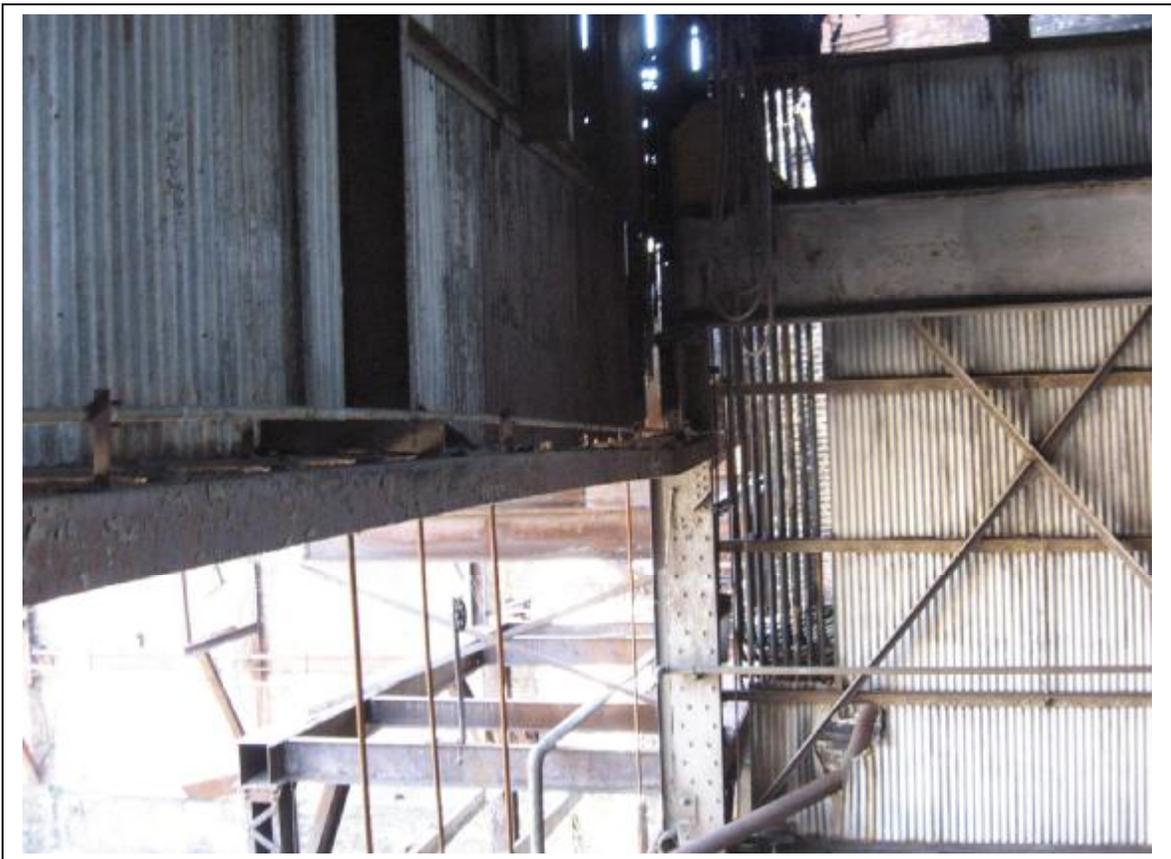
Photo 26: Building #3 deformed edge beam on column line 1

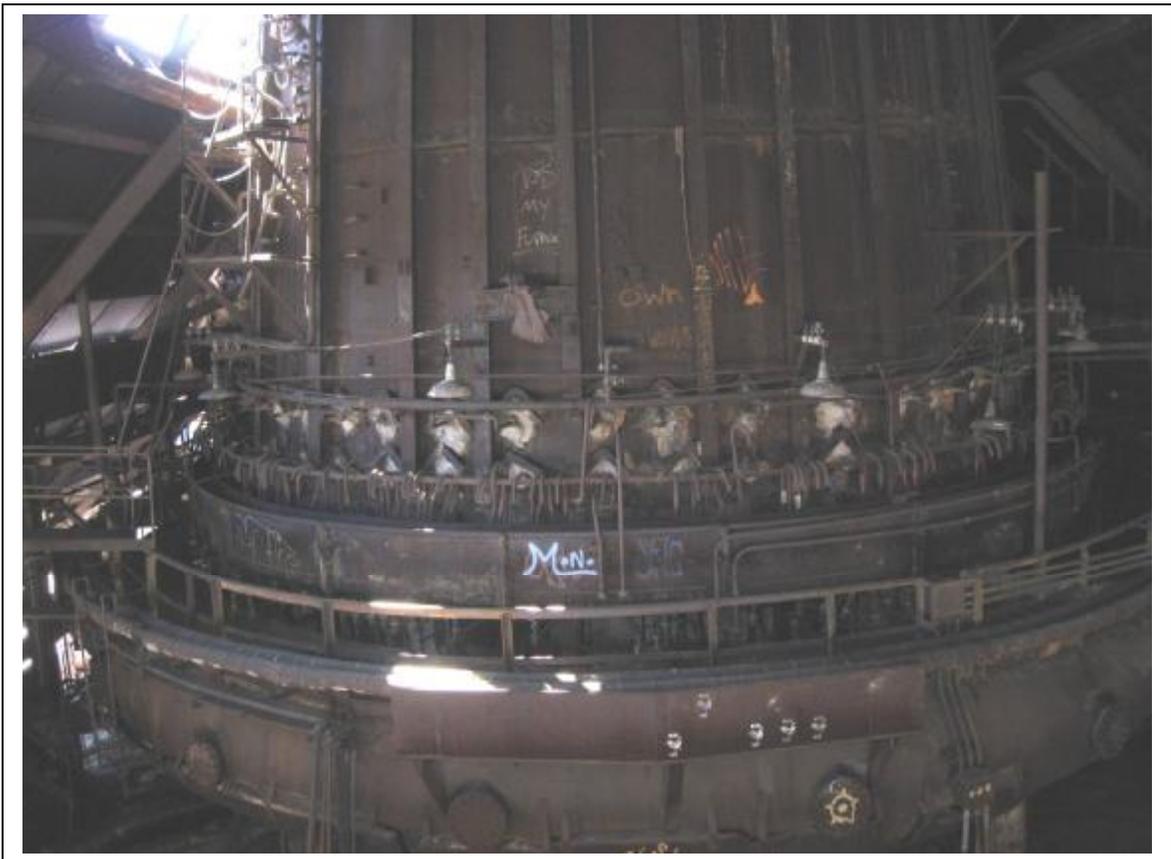
This furnace appears to be the newer of the two furnaces on the site. The furnace itself is in fair condition with minor surface rusting of the elements with no structural damage noted (See Photo 28). The column supports have minor section loss at the floor level. The walkways around the furnace are in fair condition with the walkways within Building #3 being in good condition and the walkways along the exposed portion of the furnace having increased deterioration as the level above the ground increased. The walkway at and above the "bell" level has 100% section loss of several members and severe rust packing and laminations throughout.

Photo 28: South Furnace

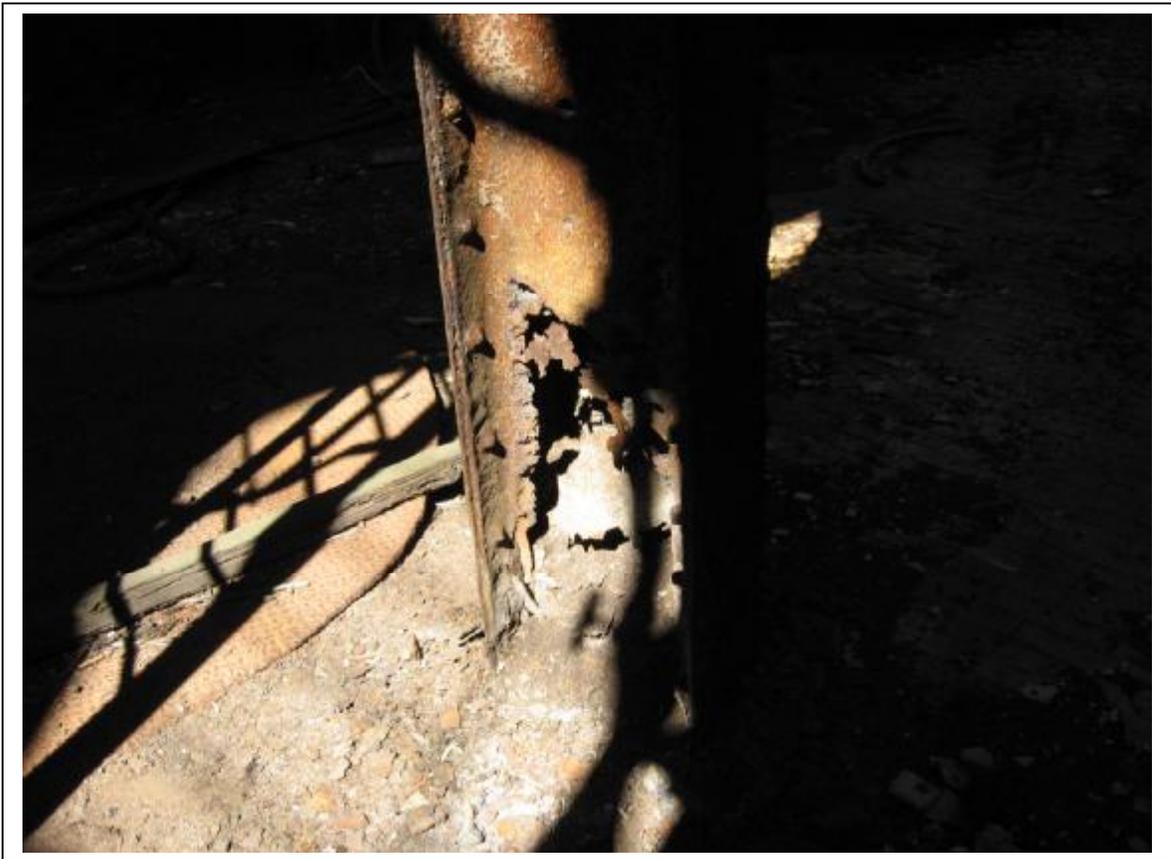
Photo 29: Dust Catcher #1 (South Furnace) 100% deteriorated webs of all four sides of column box

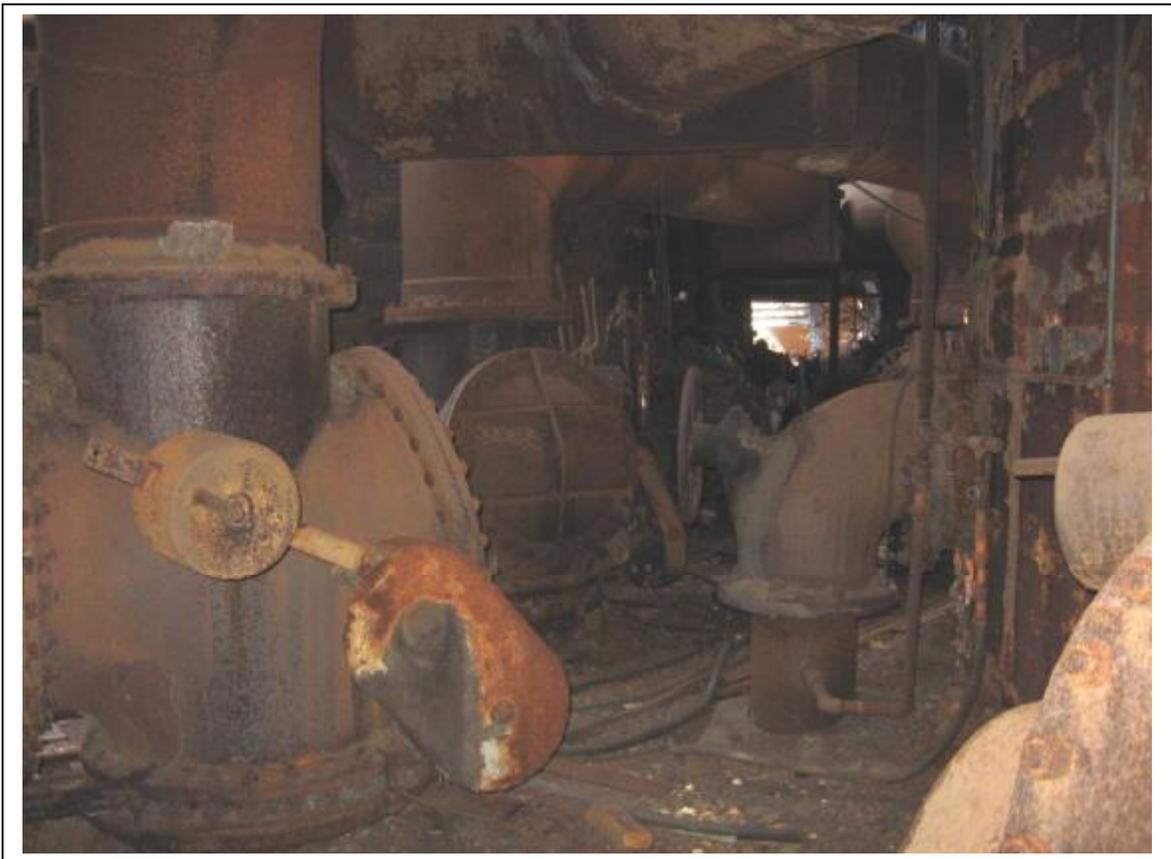
The bank of 6 stoves resides between the two furnaces (See Photo 30). The vessels themselves appear in fairly good condition with minor surface rusting throughout. The platforms around the stoves are in good condition with the exception of the platform adjacent to the dust catchers/electrical precipitators and the stock house. These platforms have heavy deterioration are in imminent failure condition and need to be replaced. All other elements in the stove area appear to be structurally sound.

Photo 30: Stoves – area between the stoves

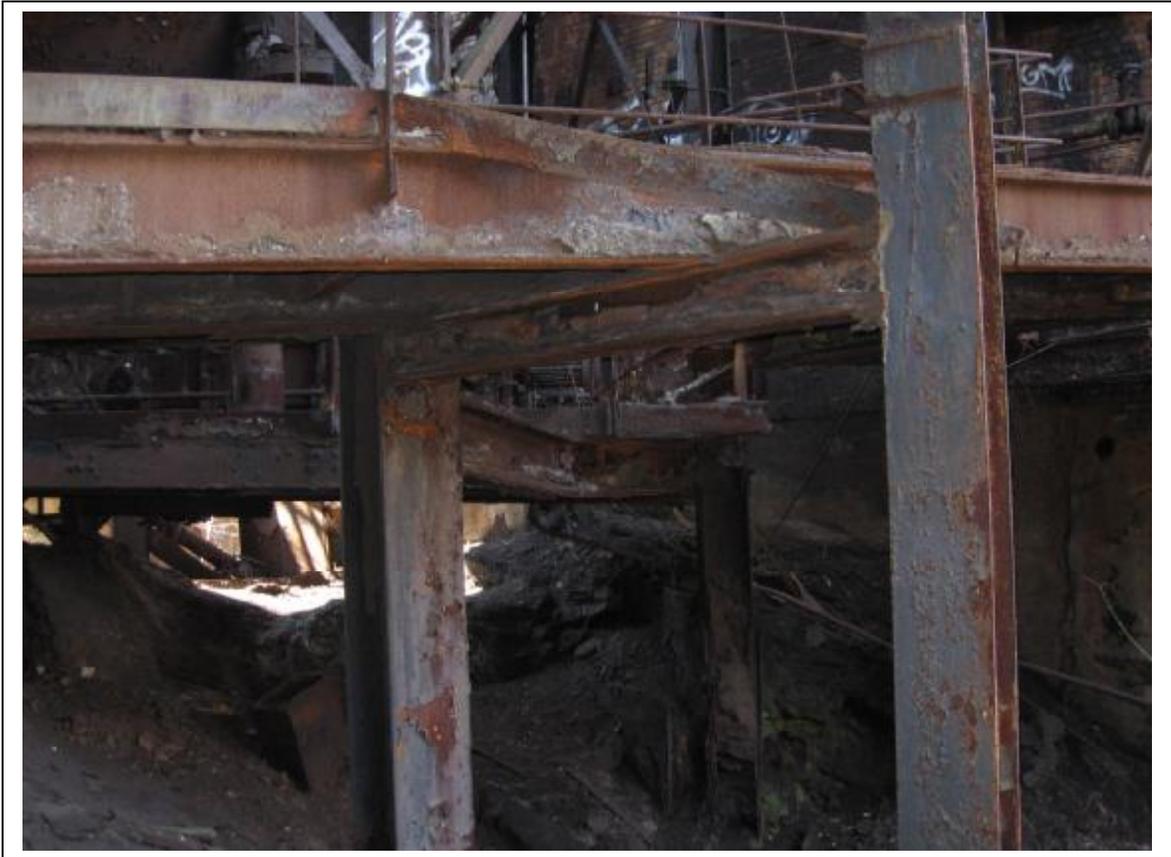
This vessel sits adjacent to the north furnace, to the south. The vessel itself appears to be in good condition with moderate surface rusting. The column supports are in fair to poor condition with heavy section loss (See Photo 32). Generally, the walkways around the vessel have partially collapsed with the remaining walkways in danger of collapsing (See Photo 31). This platform/walkway needs to be removed.

Photo 31: Dust Catcher #2 (North Furnace) Partially collapsed beam and walkway

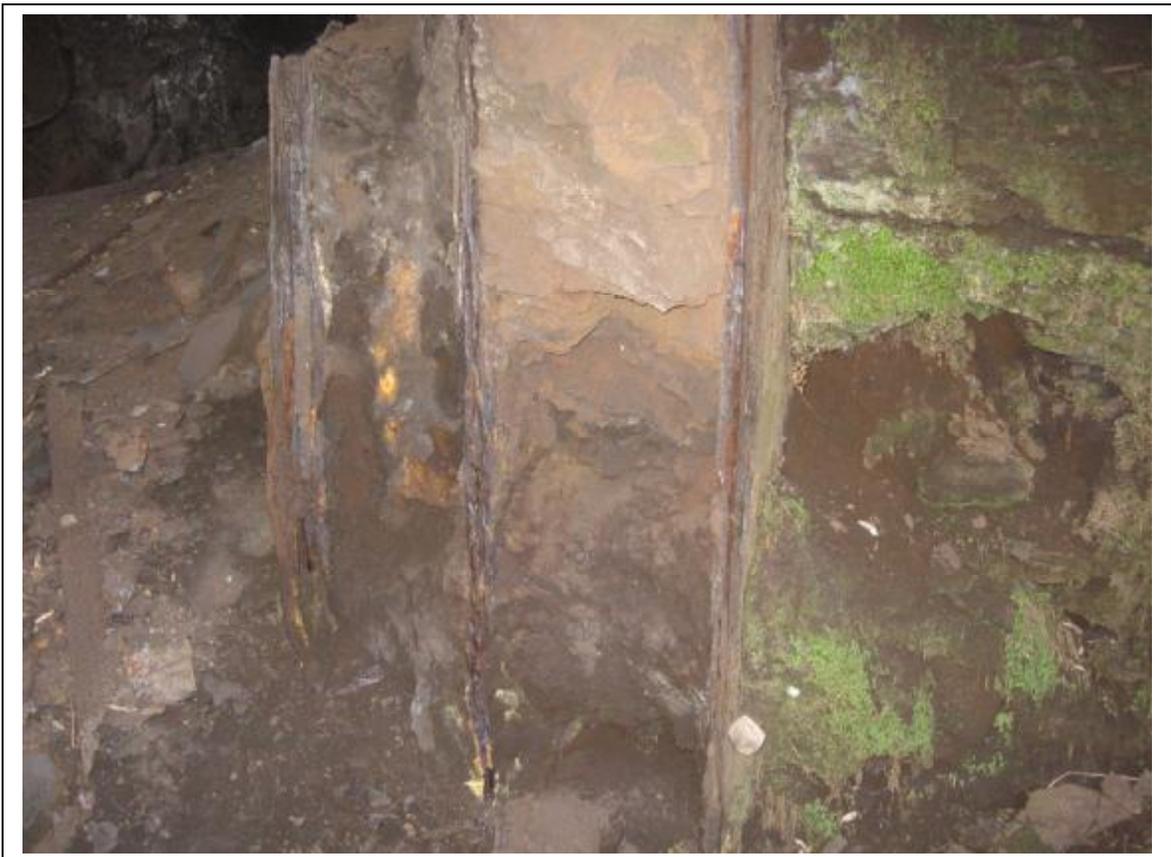
Photo 32: Dust Catcher #2 (North Furnace) Section loss to northern most support column

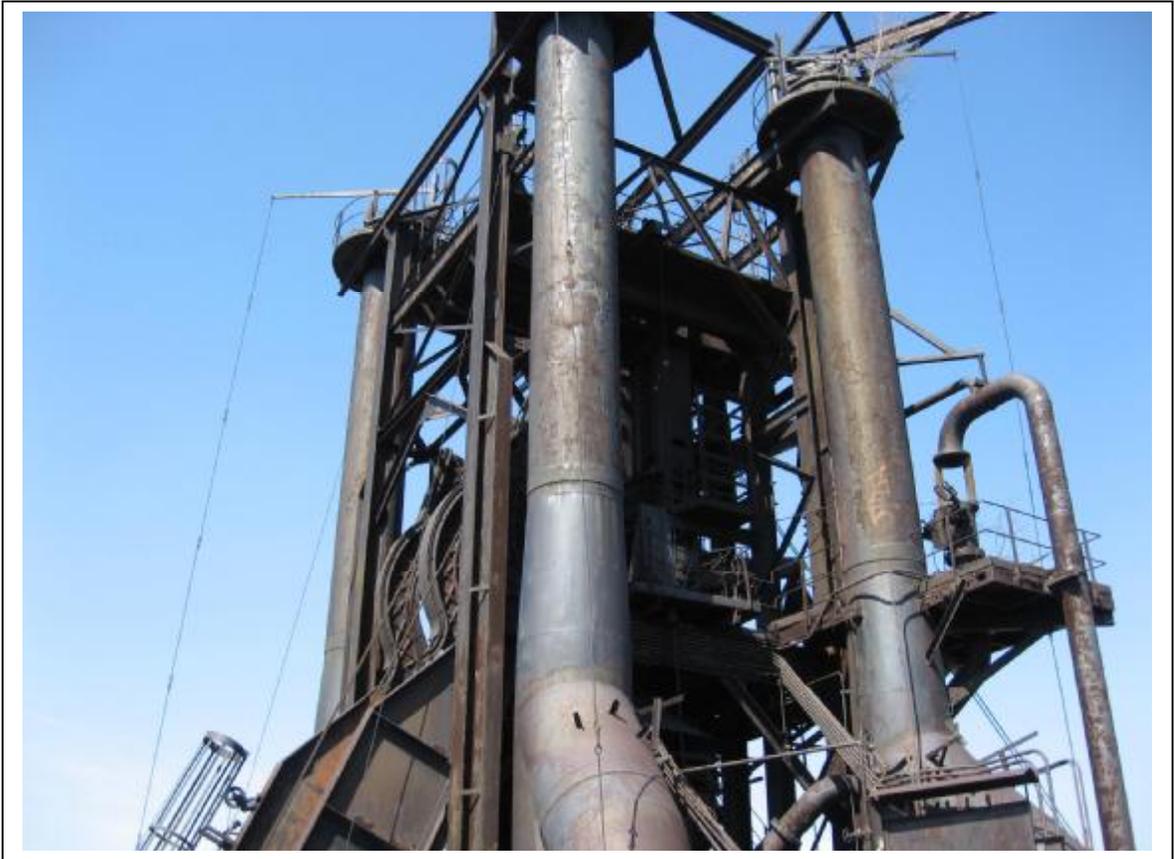
The north furnace appears to be the older of the two and has some heavier rusting and deterioration with minor section losses along the face and at some of the walkway supports (See Photo 33). The visible portion of the furnace foundation has some diagonal cracking and spalling.

Photo 33: Top of North Furnace

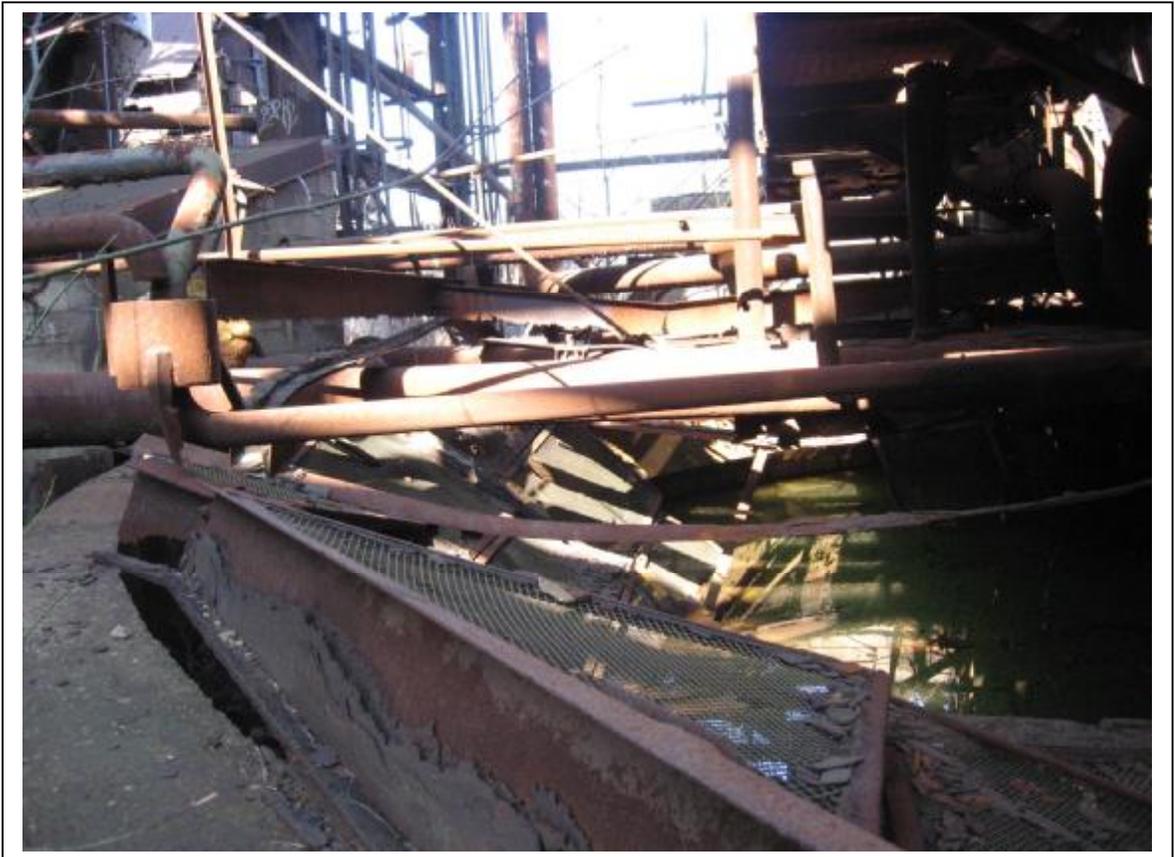
Photo 34: Gas Washers/Electrical Precipitators collapsed and heavily deteriorated members

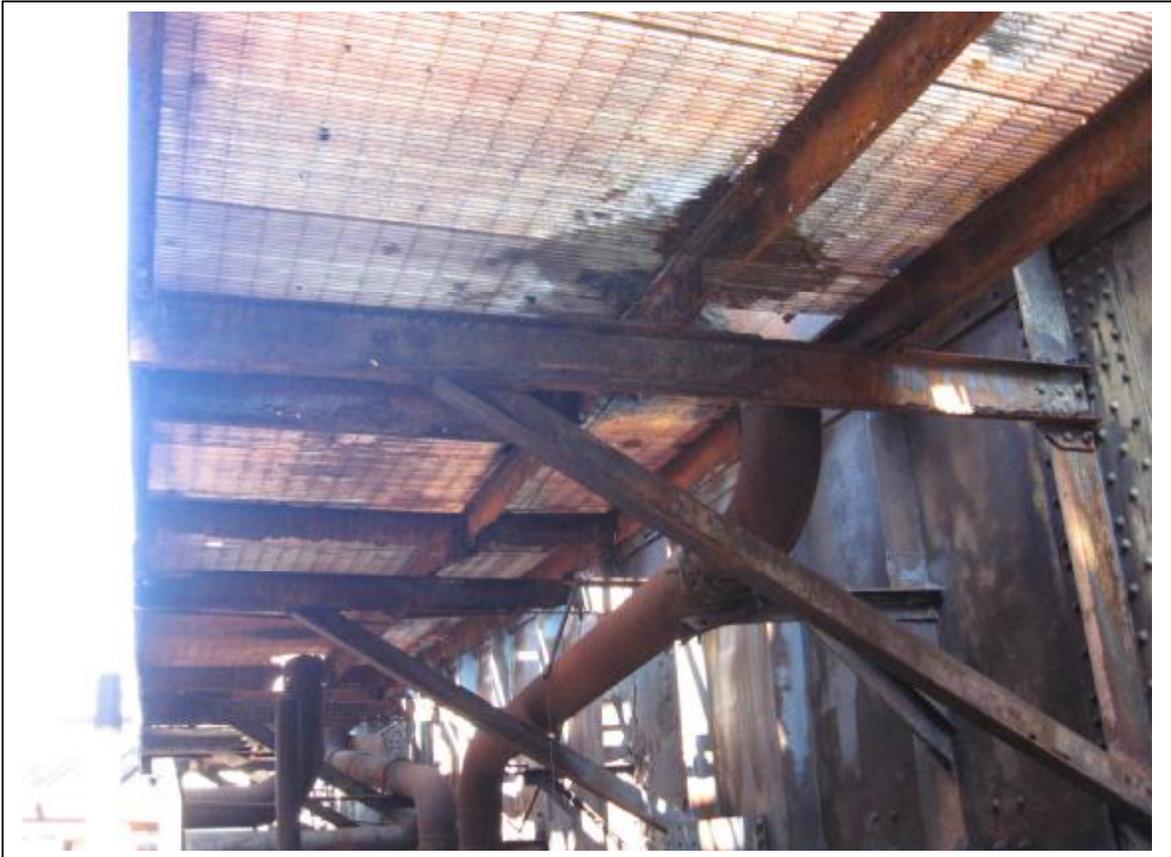
Photo 35: Gas Washers/Electrical Precipitators heavily deteriorated support member for platform

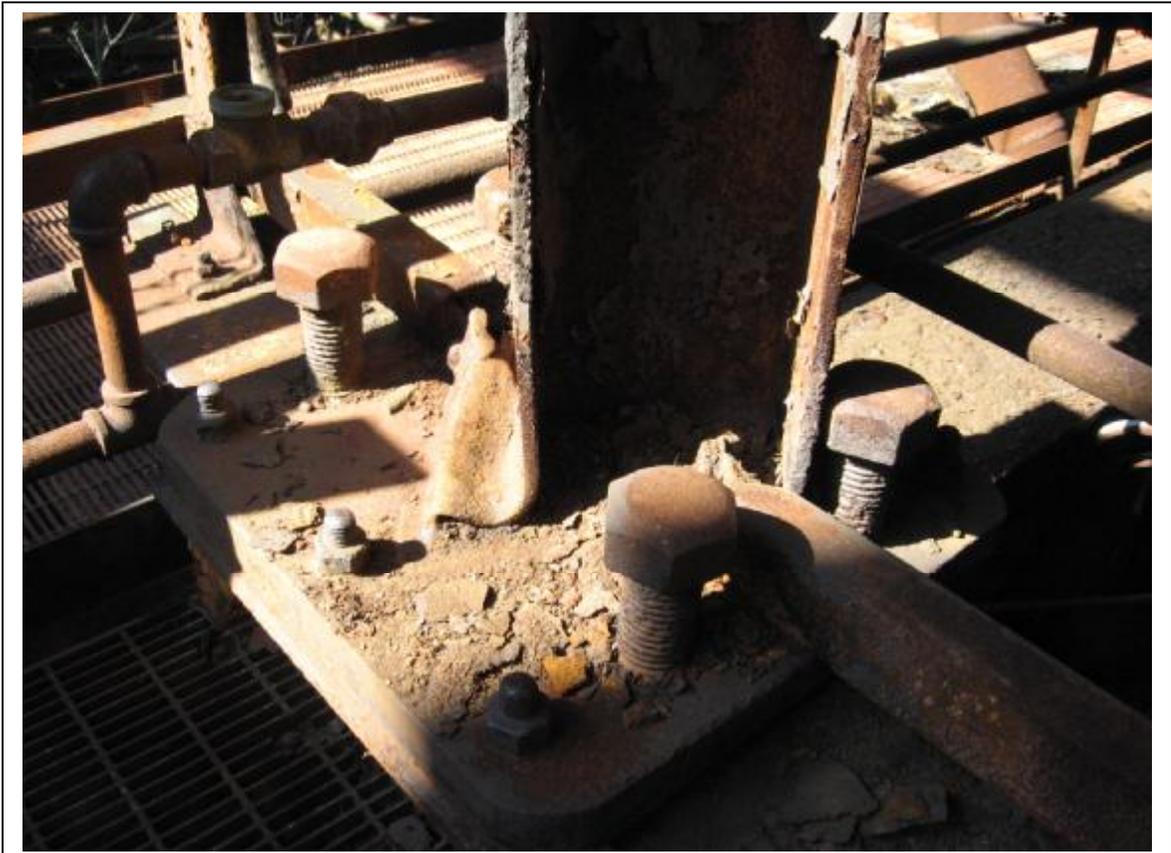
Photo 36: Gas Washers/Electrical Precipitators buckled and advanced deterioration of column that supports the south electrical precipitator

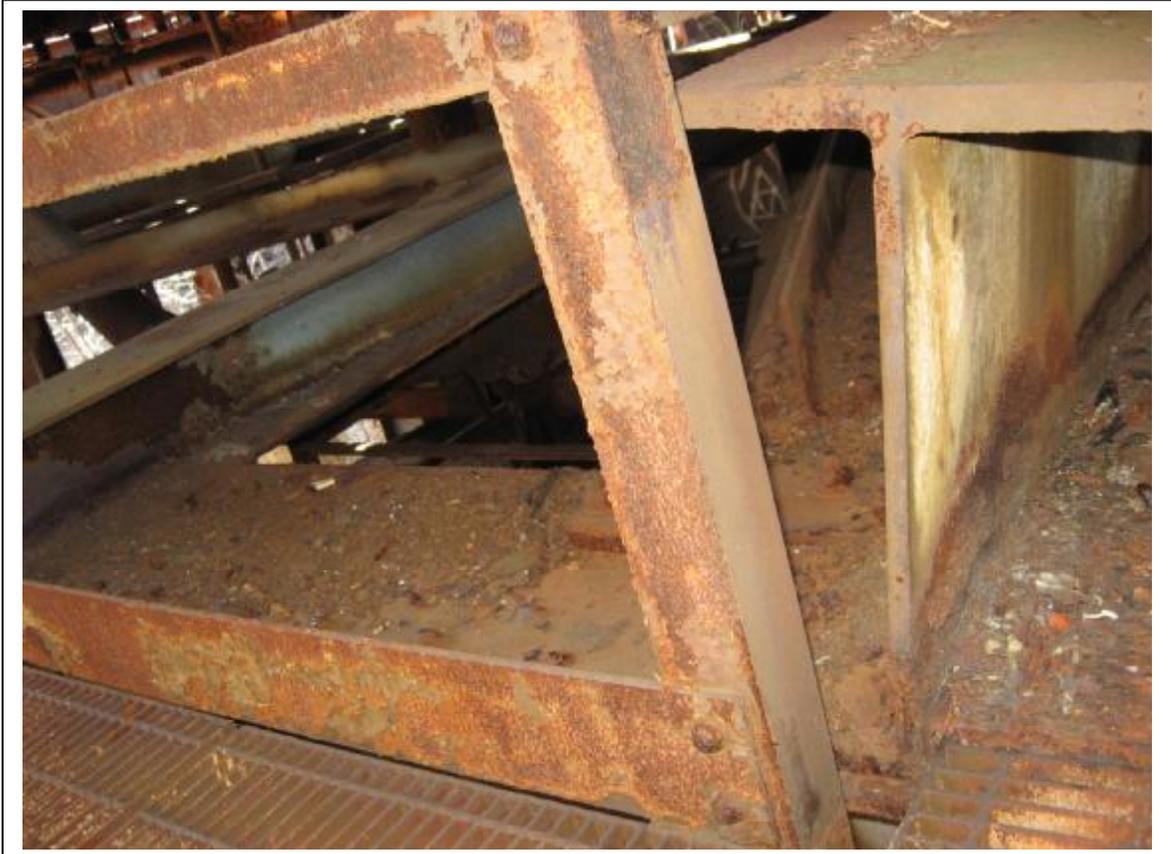
Photo 37: Gas Washers/Electrical Precipitators buckled and rotated support beam located at NE corner of south

electrical precipitator

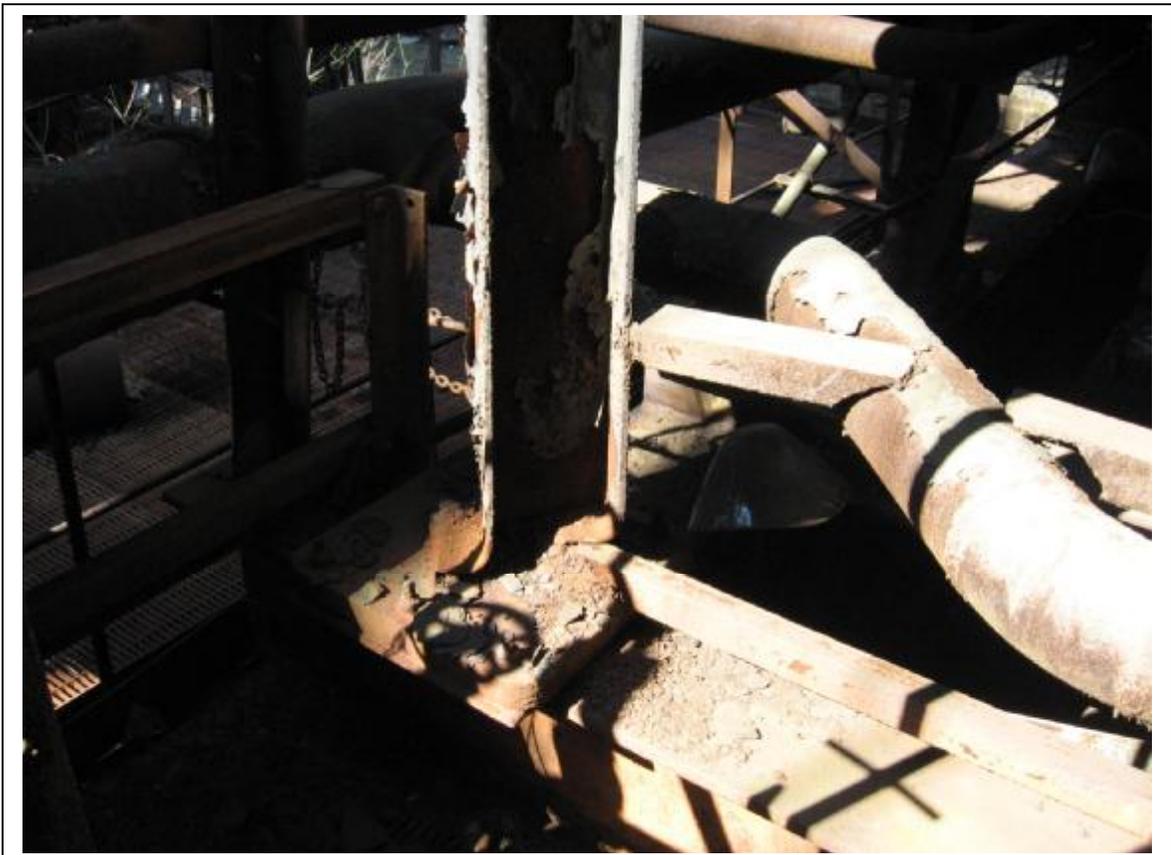
Photo 38: Gas Washers/Electrical Precipitators buckled and advanced deterioration of column that supports the north electrical precipitator

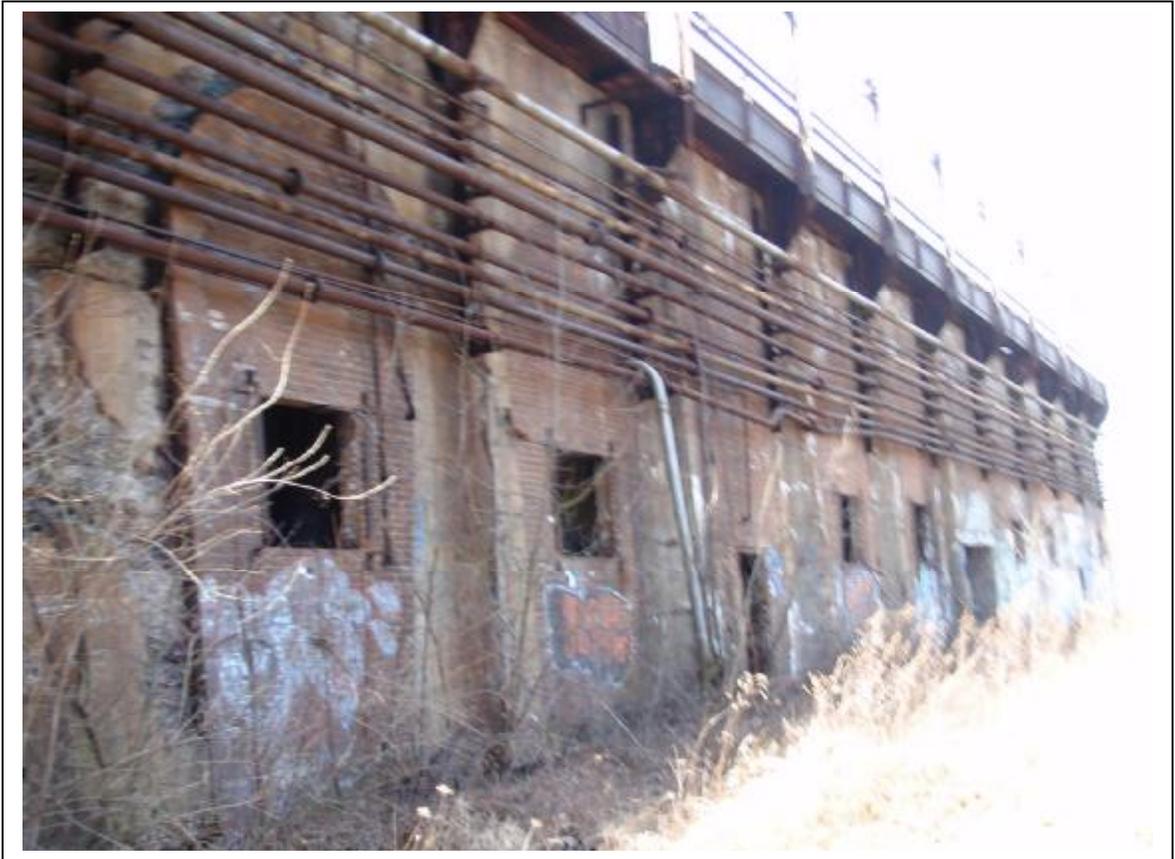
The concrete walls have diagonal cracking and areas of advanced section loss and spalling throughout and are generally in poor condition (See Photos 41 and 42). The area under the bins is in fair condition. The pit areas where the skip hoists were loaded are filled with water and the platforms in the operator's areas have damaged members and the north skip bridge has collapsed (See Photos 43 and 44). The walkway over the pit at the north skip bridge has partially collapsed.

Photo 41: Stock House Exterior elevation

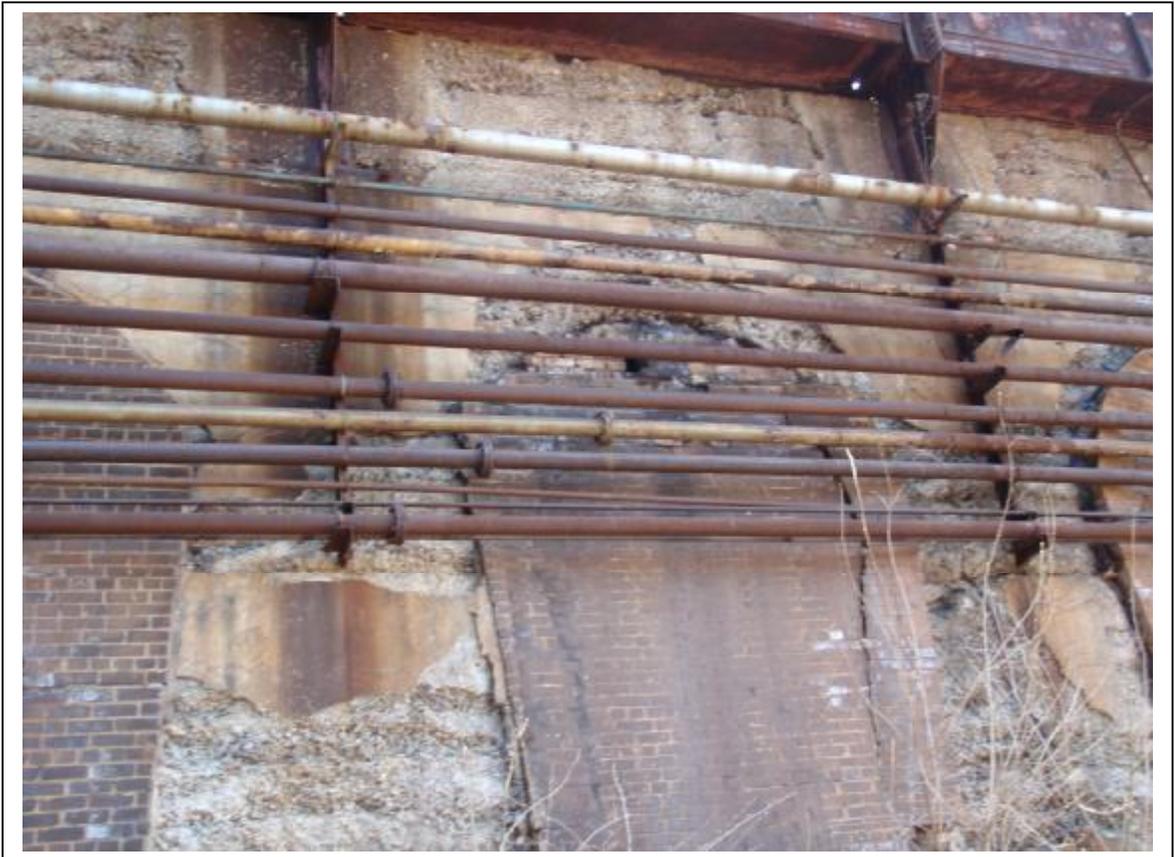
Photo 42: Stock House typical condition of wall

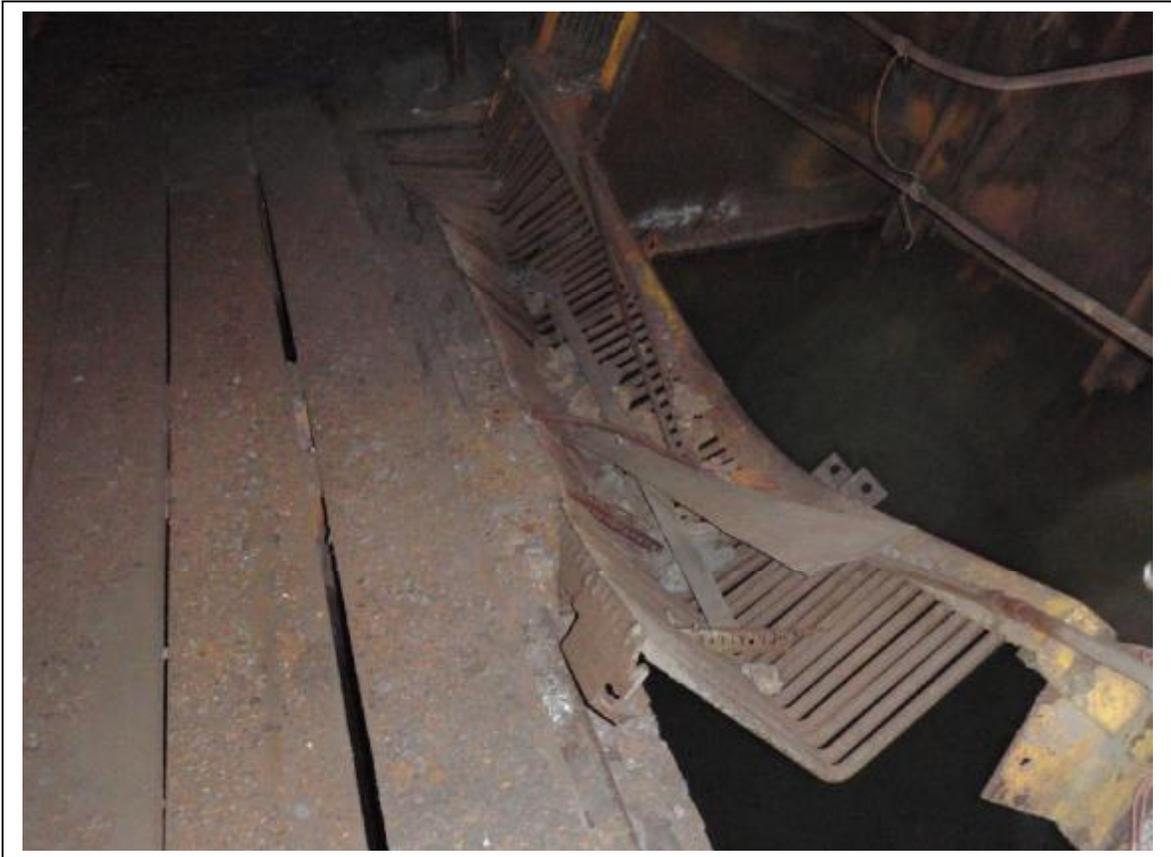
Photo 43: Stock House partially failed bridge at south skip bridge in Stock House

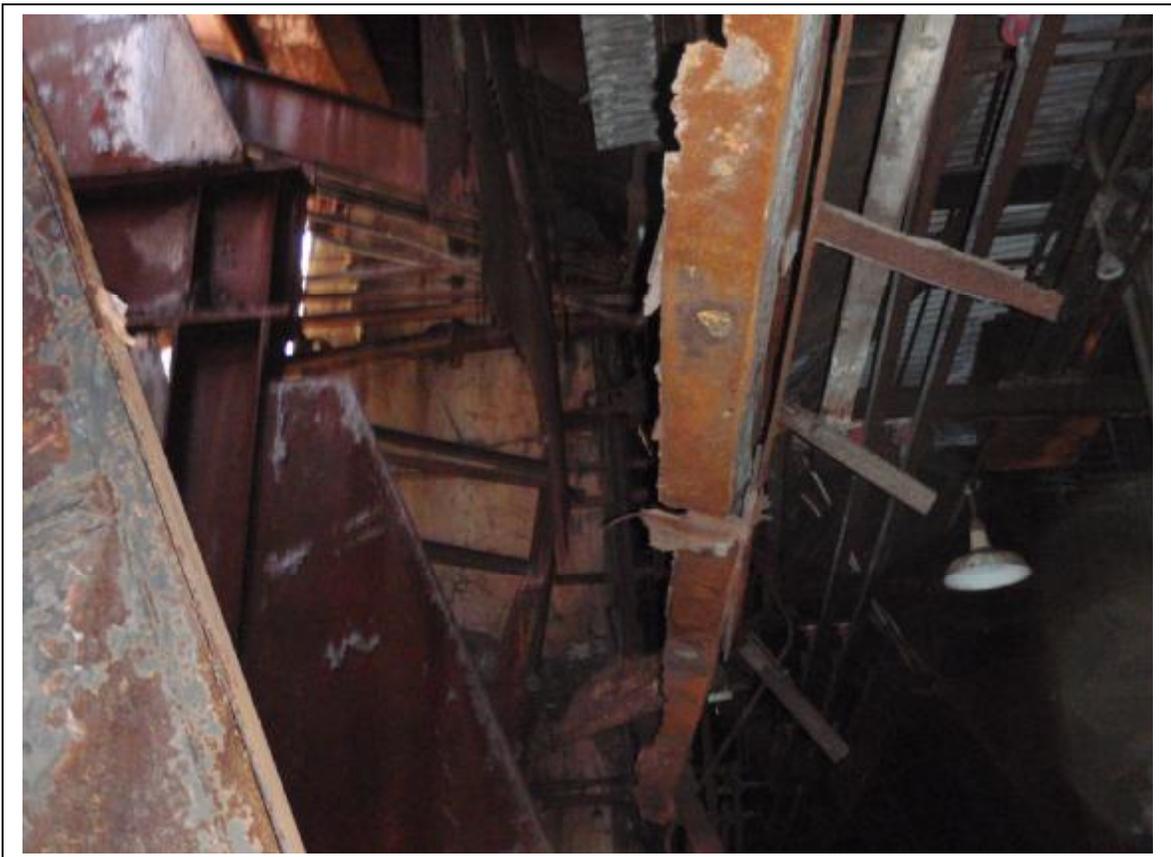
Photo 44: Stock House failed platform at skip bridge

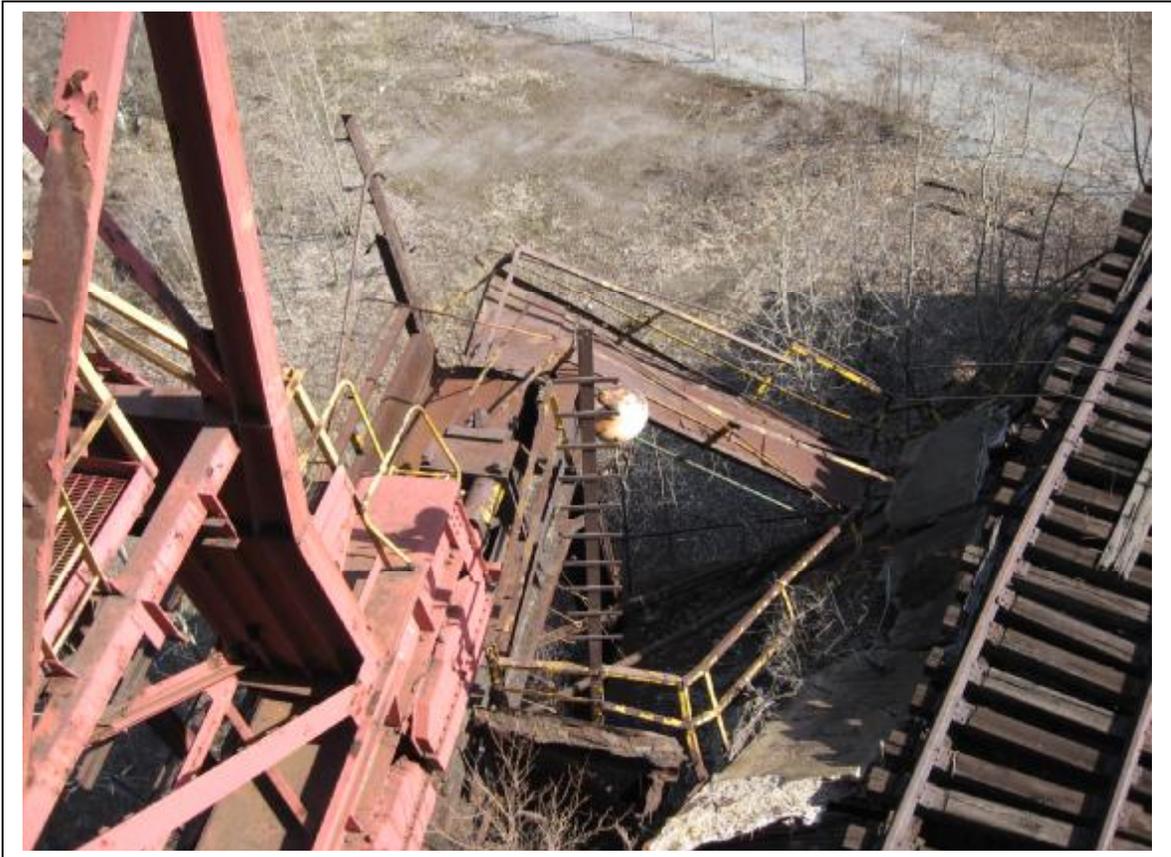
Photo 45: Stock House collapsed walkway at south end of Stock House

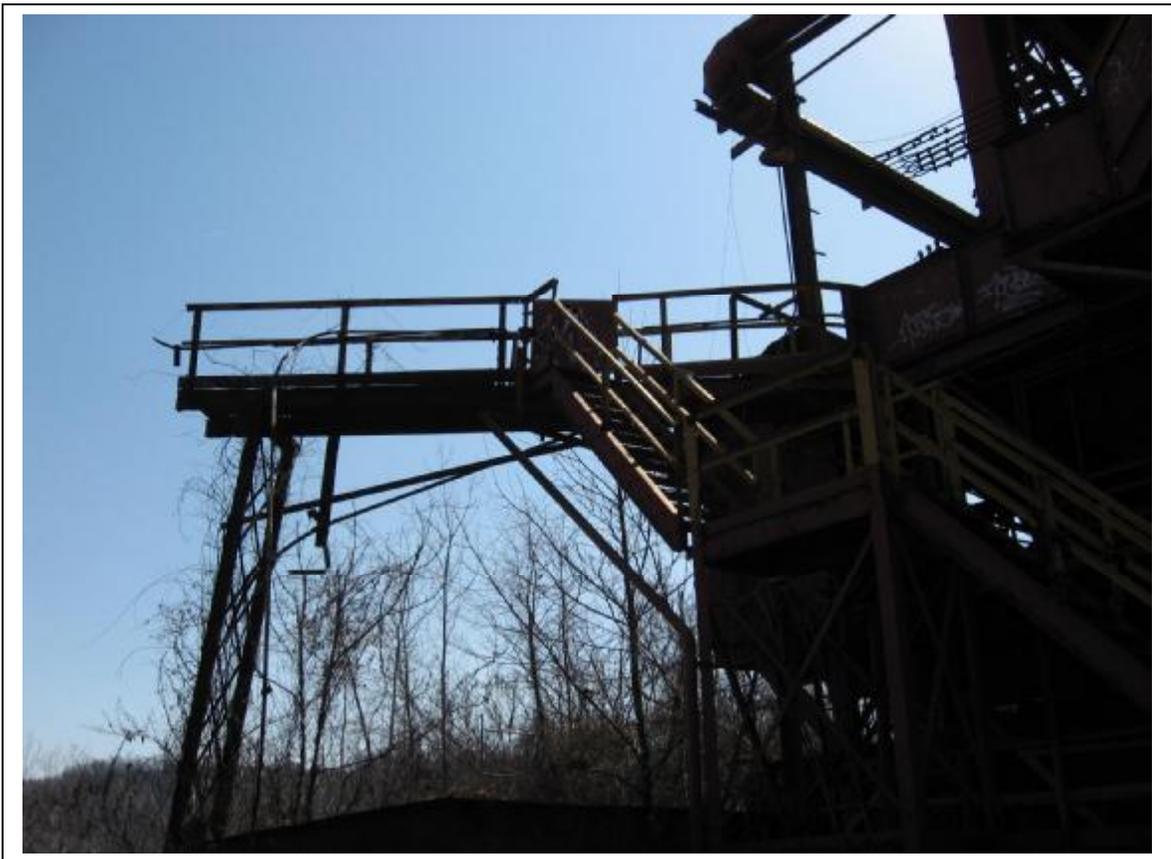
The third level has a walkway which led to a structure which has been demolished. The support pier is not connected to the walkway and is 3' out of plumb (See Photo 46). The walkway is unstable and appears ready to collapse. The third level control room has a wood floor which is rotted. The fourth and fifth levels have some deterioration of the stairs and platforms.

Some repairs need to be performed in building #7 to stabilize the walkways and make the area safe.

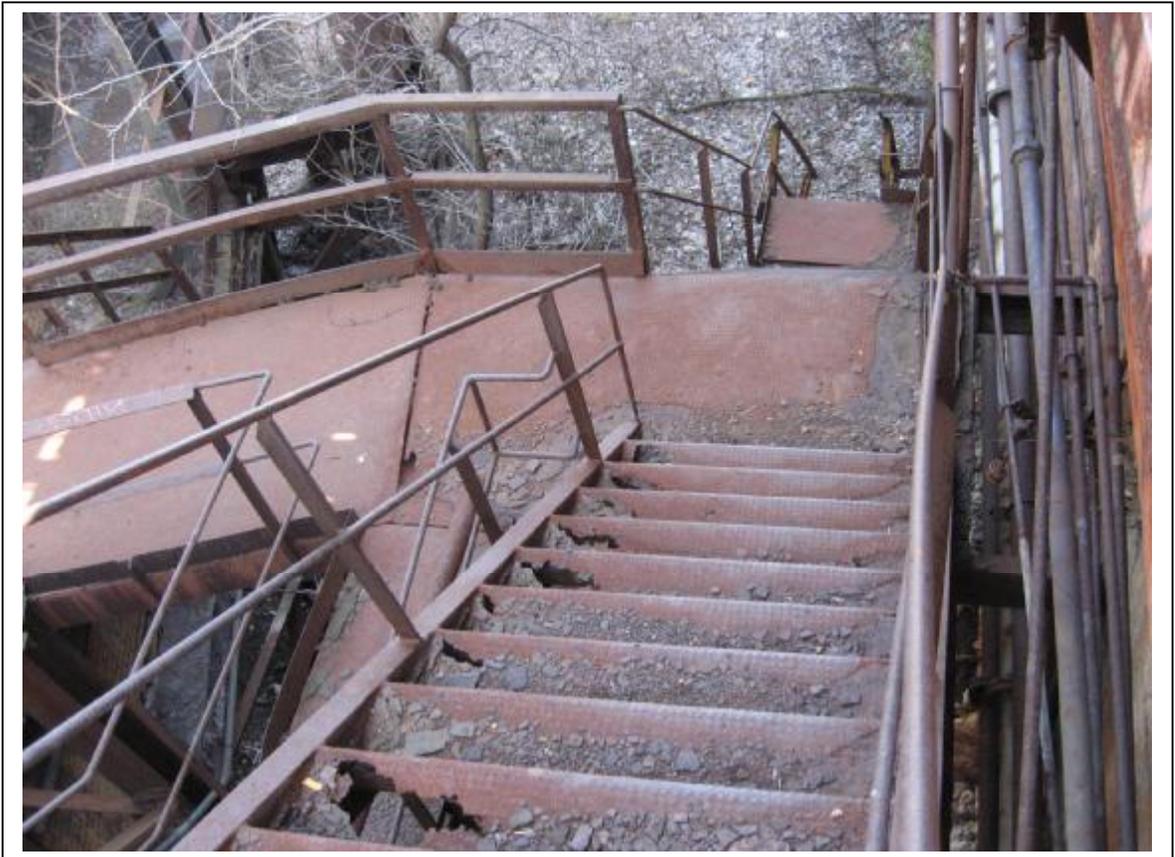
The east tower is in fair condition with some minor surface rusting of the stairways. A stairway which is on the furnace side (east) of the tower is in imminent failure condition and in danger of collapse (See Photo 48). This stairway should be removed and replaced. Other stairs on the east side of the ore bridge has loose step and loose handrail.

Photo 48: Stair at furnace side of Ore Bridge in unsafe condition
