**Carrie Furnace Site Redevelopment  
Phase II**

**Carrie Furnace Facilities**

**Re-Inspection and Revision Report  
April 2009**

**Wilbur Smith Associates**

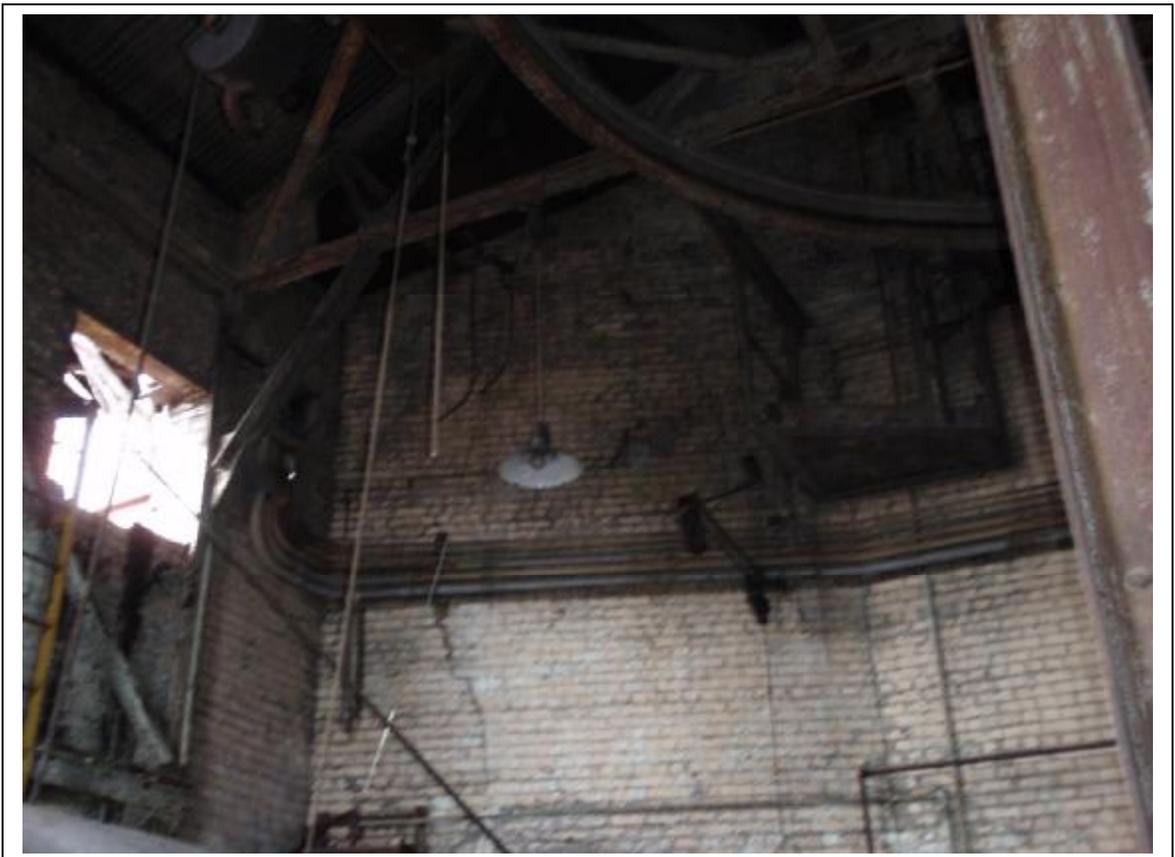
Photo 50: Skip Hoist Motor Building for South Furnace crack in north wall

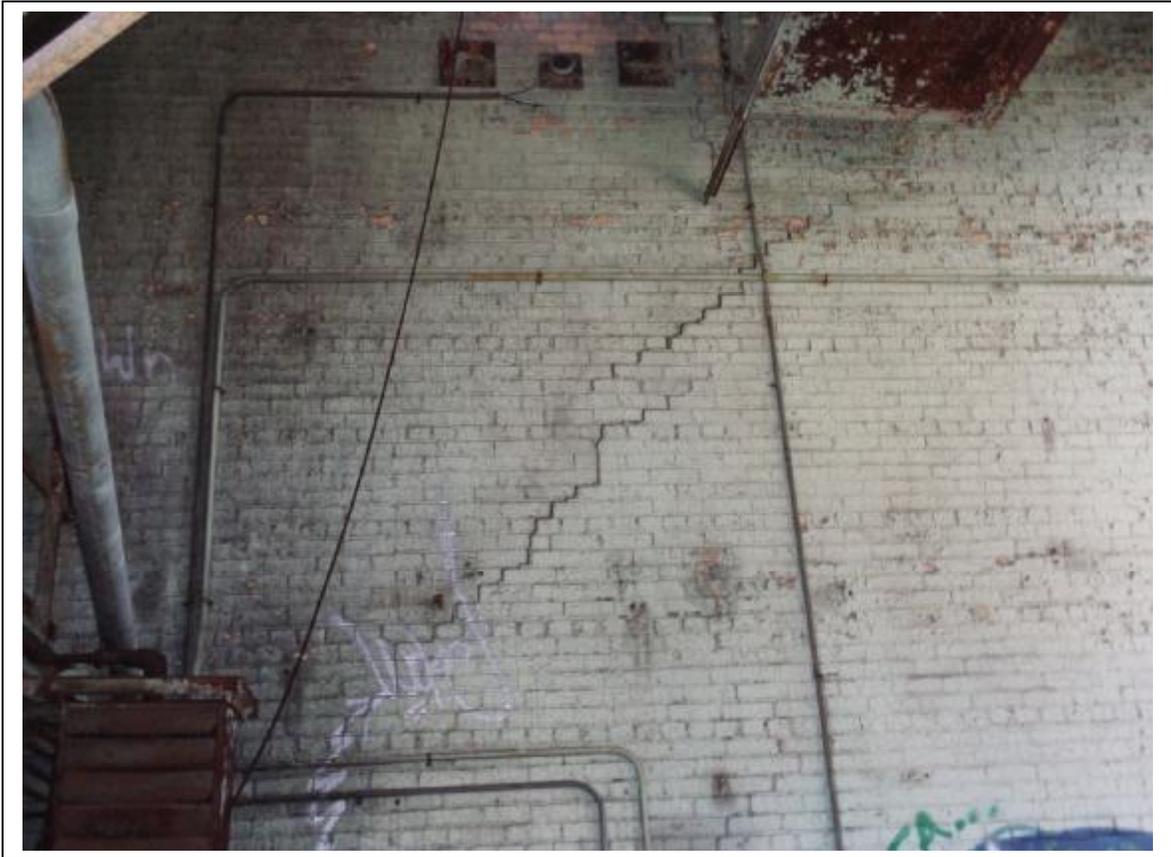
Photo 53: Skip Hoist Motor Building for North Furnace crack in wall

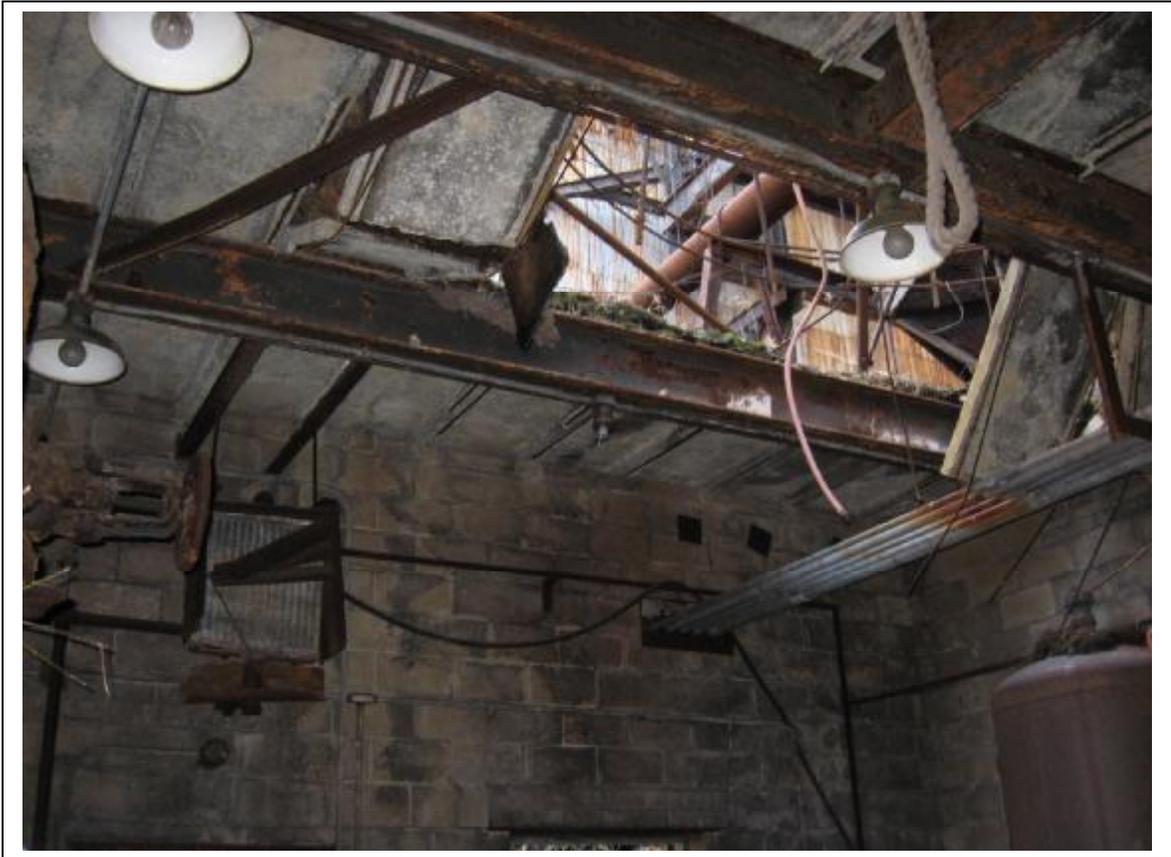
Photo 55: Masonry Building #1 partially collapsed roof and hanging heater unit

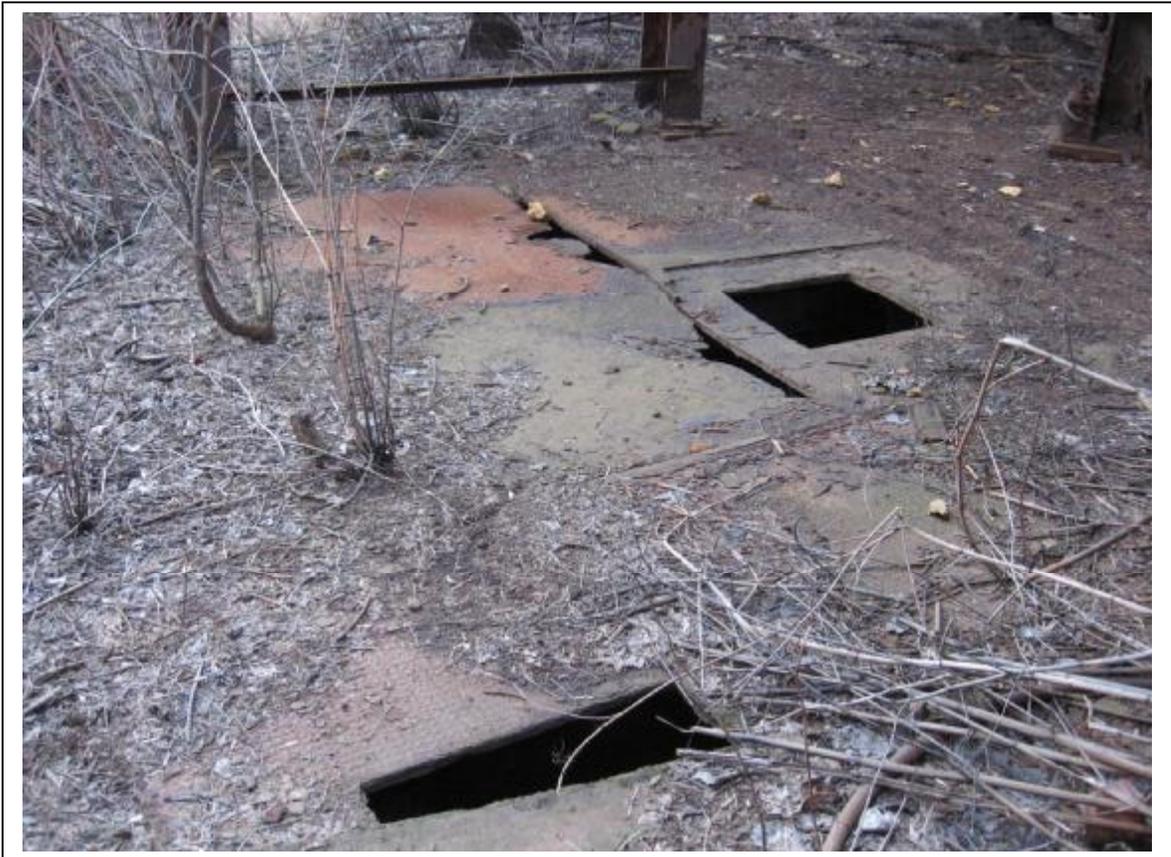
Photo 58: Steel plates covering pit near Masonry Building #1 deterioration

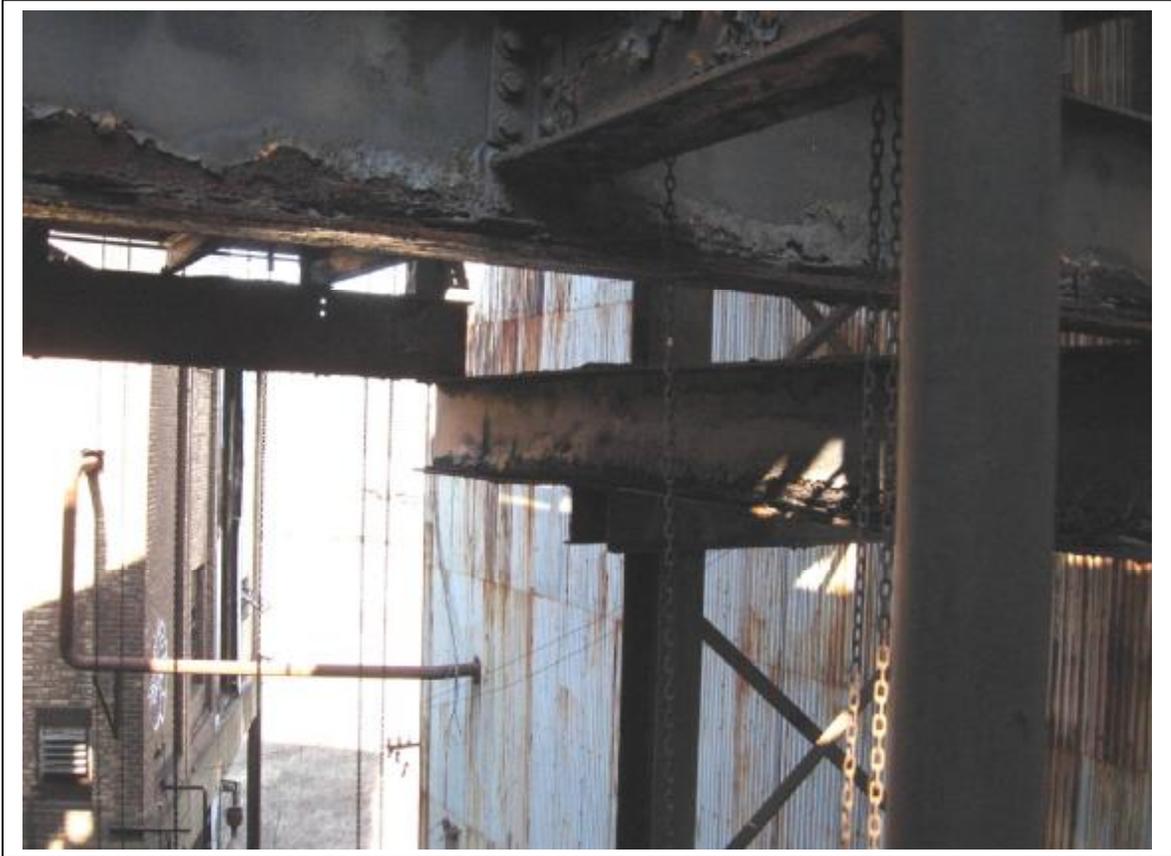
The platforms at the base of the vessels are over the pool. The platforms condition is imminent failure condition with heavy deterioration and section loss on nearly all elements of the platform system. Portions of the platforms have already collapsed into the pools (See Photos 34 and 35). The platforms and walkways at higher levels above the pool are in critical to serious condition (See Photo 59).

Photo 59: Walkway and pipe support beam between electric precipitators and Building #2 with beam deformation,

yielding and web “crushing”

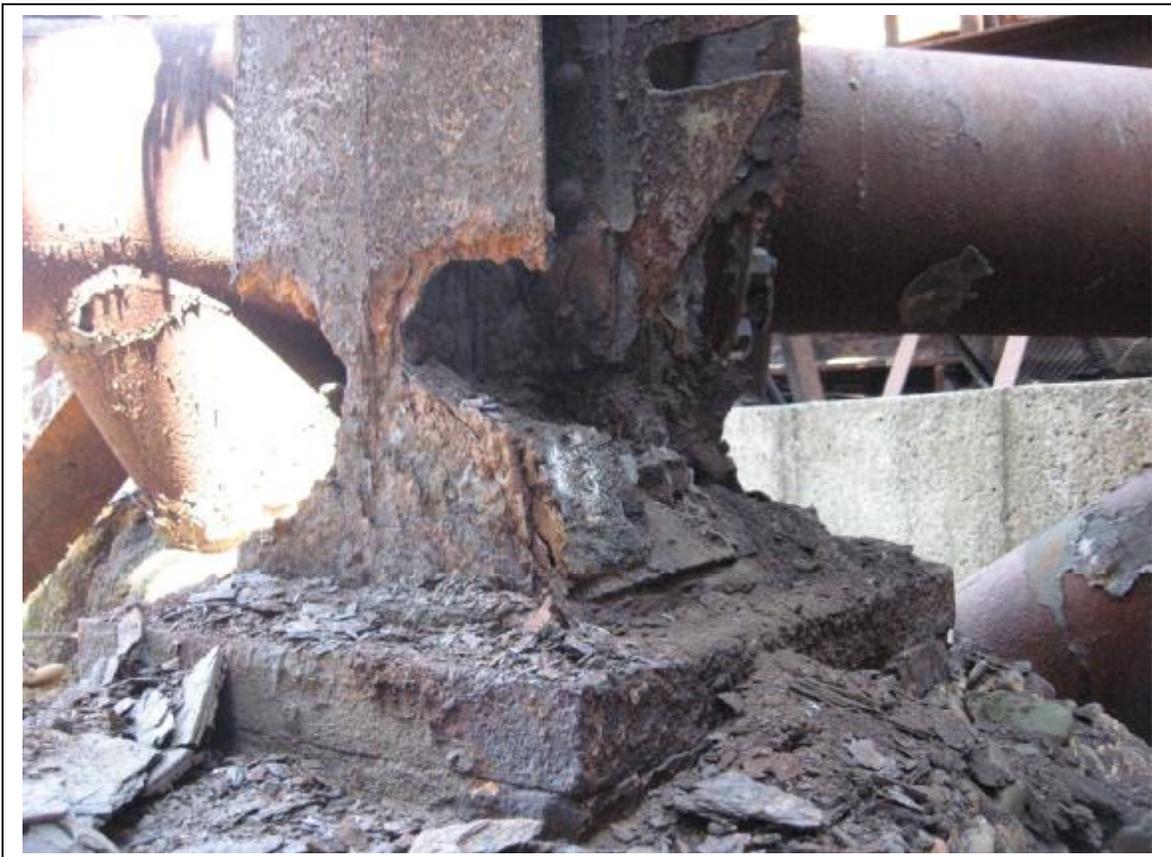
Photo 60: Southern column of tower for pipe support tower between electrical precipitator, and Masonry Building #1 and #2 with critical section loss

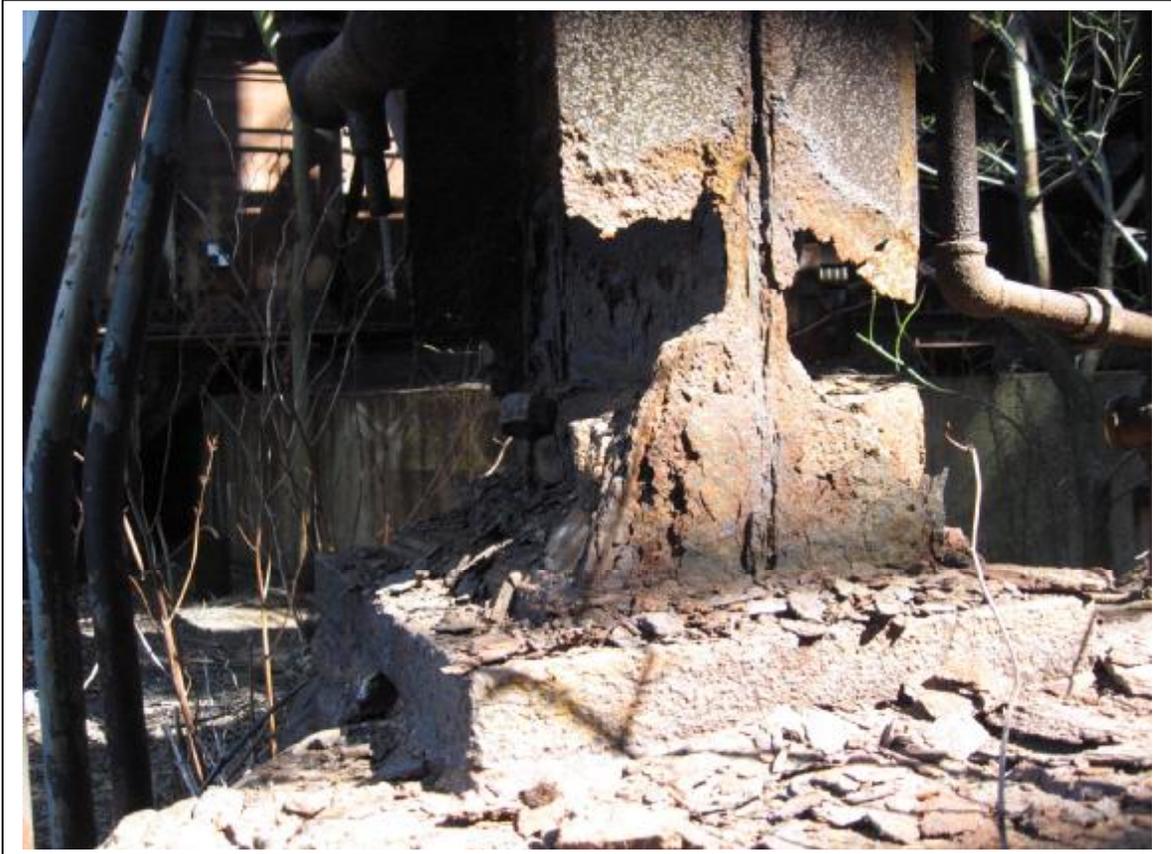
Photo 61: North column of tower for pipe support tower between electrical precipitator, and Masonry Buildings #1

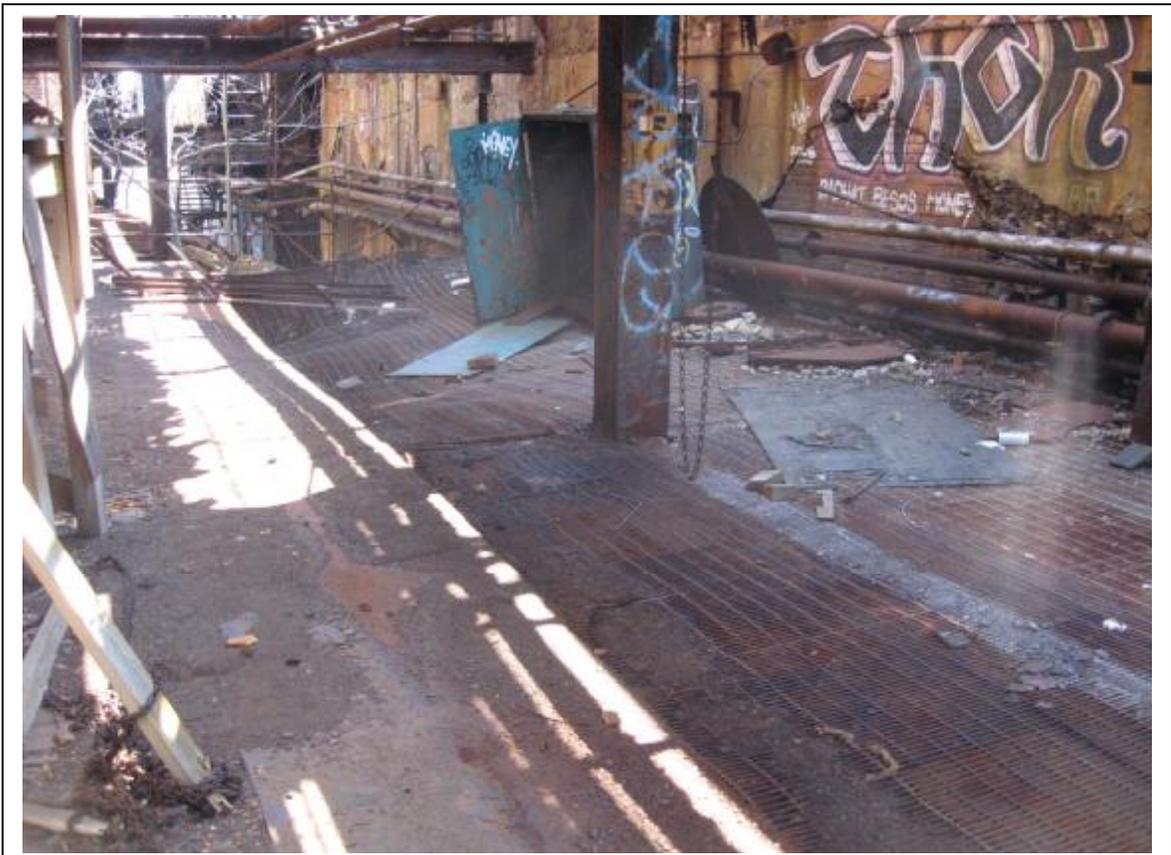
The walkway between the stoves and the stock house has collapsed. Portions that remain are in imminent failure condition (See Photos 62, 63 and 64).

and #2 with critical section loss  
Photo 62: Walkway between Stoves and Stock House partially collapsed, deformed and settled

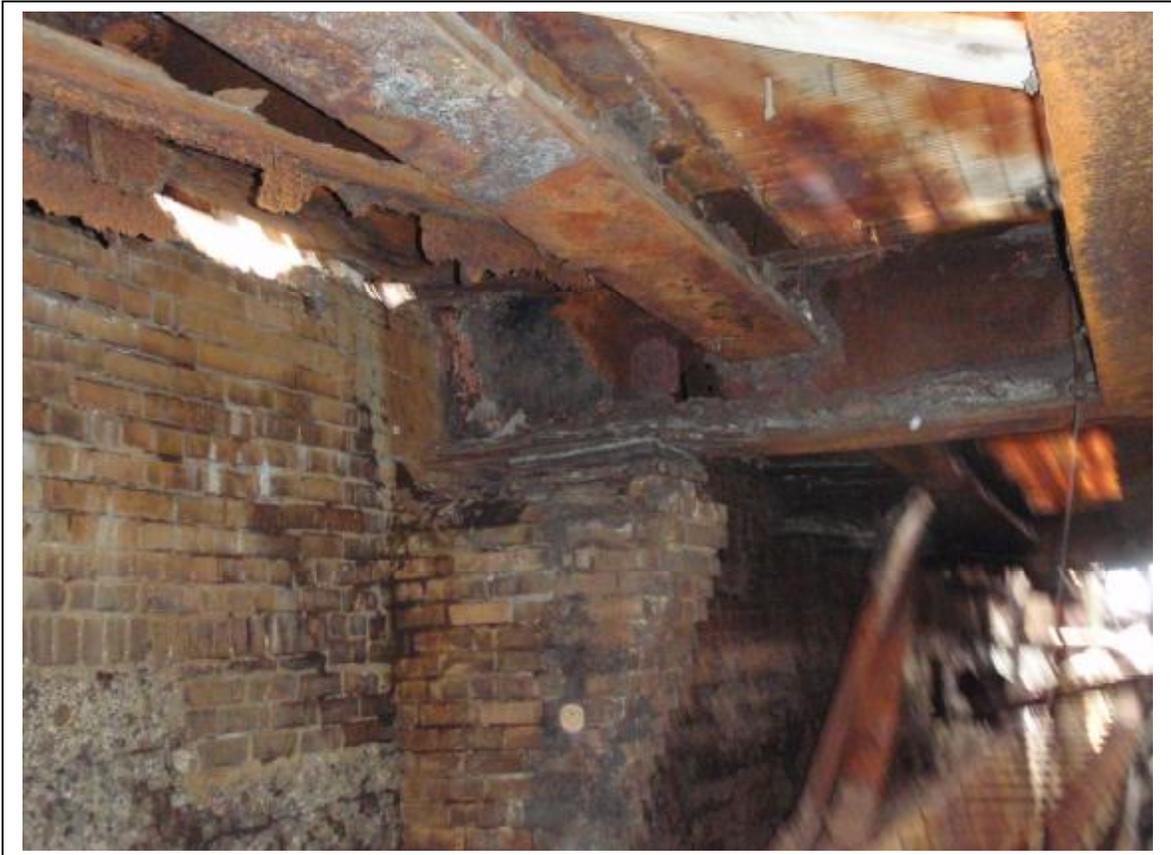
Photo 63: Underside of walkway between Stoves and Stock House partially collapsed, deformed and settled

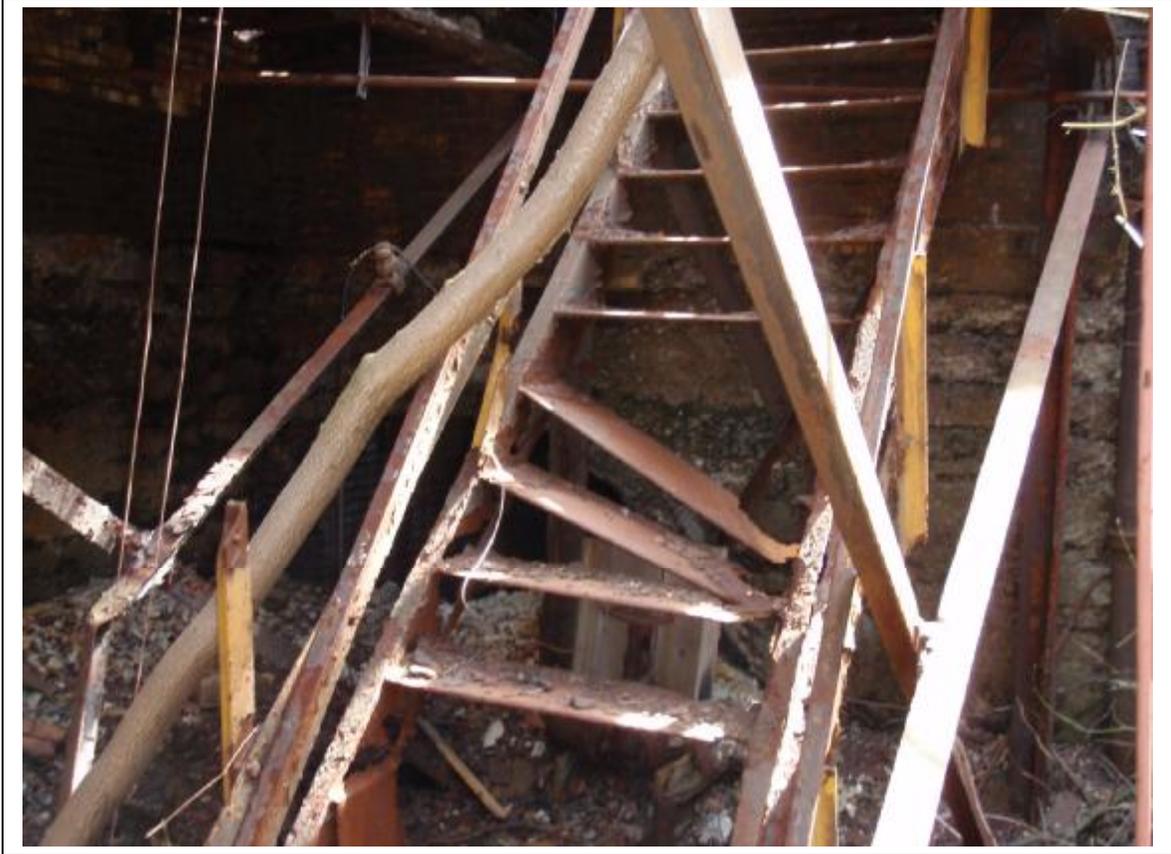
Photo 64: Stairway near north furnace and dust collector collapsed, deformed and settled

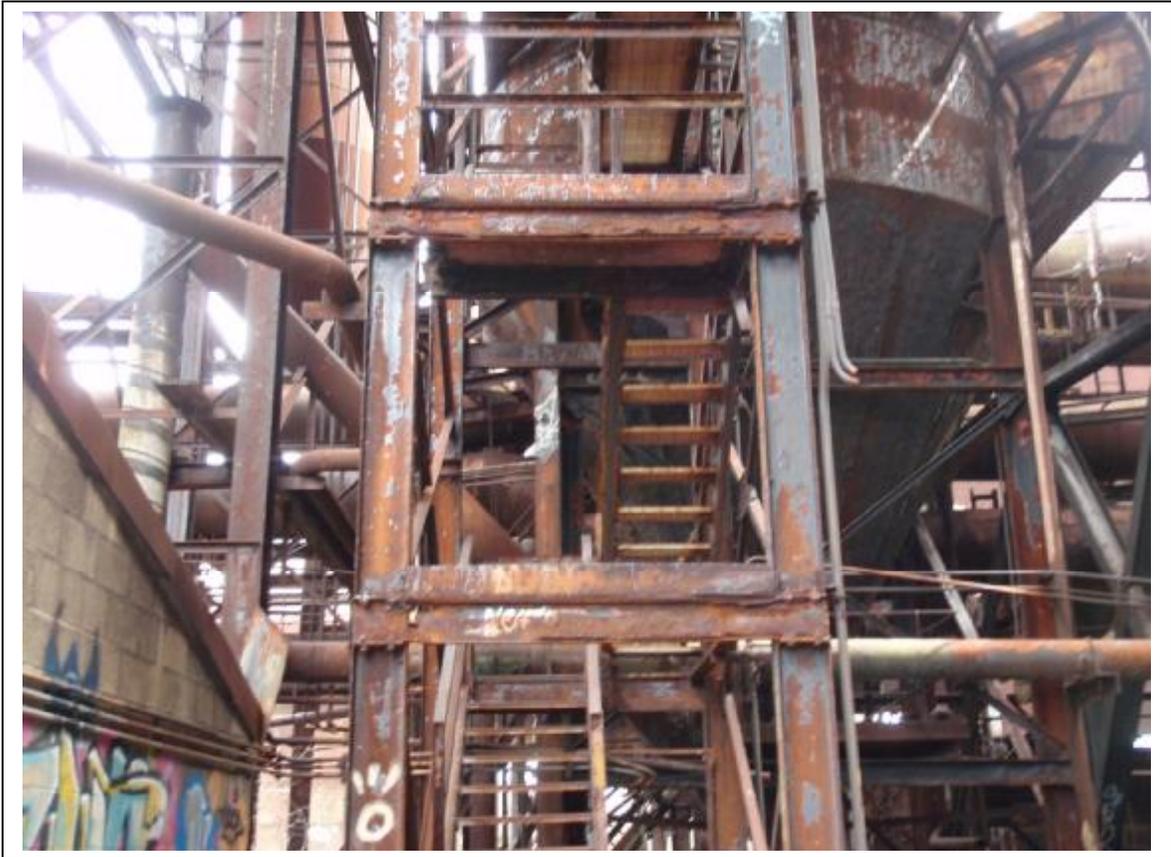
Stair tower between electric precipitators and gas washers is severely deteriorated with nearly 100% section loss to many members, including column webs and most horizontal members (See Photo 65). It appears to be in imminent failure condition and presents a hazard. A pipe support tower between electric precipitators and gas washers (between Masonry Bldgs. # 1 and #2) has heavy deterioration; including 100% section loss at the base plates (See Photos 60 and 61). Lateral bracing members have section loss such that they are ineffective and present hazards.

Photo 65: Stair near Electrical Precipitator advanced section loss on members

Major repairs will be required in this area to restore or remove the vessels and the walkways to a safe condition.
