**Carrie Furnace Site Redevelopment  
Phase II**

**Carrie Furnace Facilities**

**Re-Inspection and Revision Report  
April 2009**

**Wilbur Smith Associates**

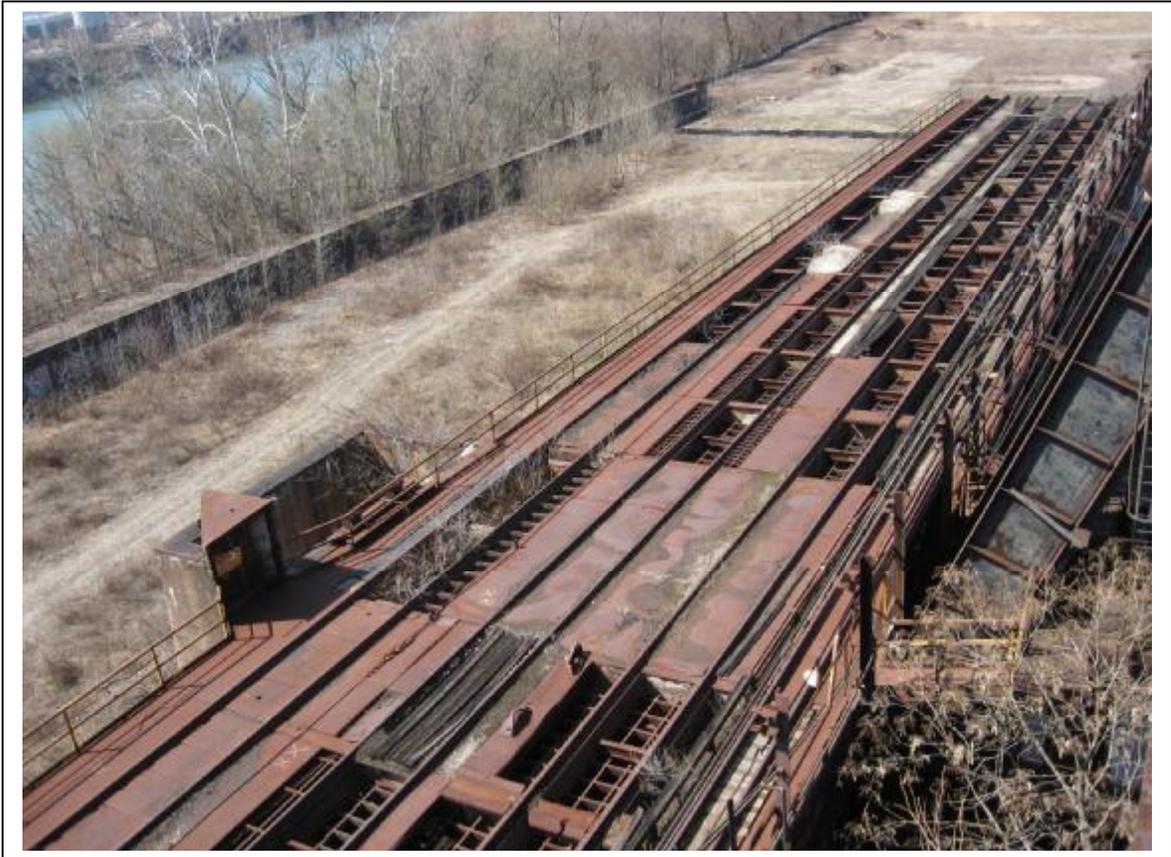
Photo 39: Stock House

The stock house area runs along the west face of the furnaces provided raw material to the furnaces by way of the skip bridge. The top of the stock house, where the railcars sat, is in fair condition with some loose rails and some rotted timbers (See Photos 39 and 40). The walkway from the stock house around the north skip bridge is in poor condition and required repair. The majority of the structure appears stable. The south end of the stock house has been partially demolished and the elements which are still remaining are unstable and in danger of collapse (See Photo 45). This area needs to be stabilized to prevent further collapse. On the upper level of the stock house, an overhead electrical rail has partially fallen and others appear to be ready to fall.

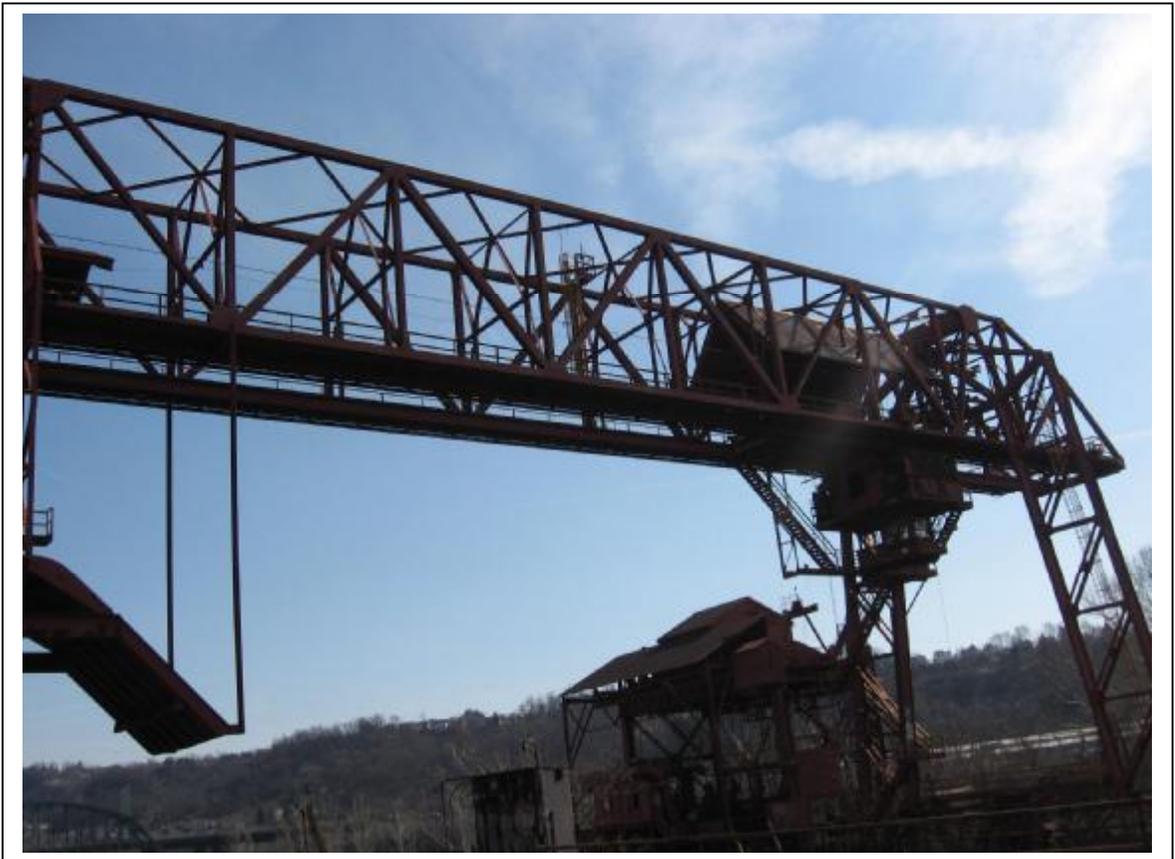
The ore bridge is made up of two access towers and the main span that houses the crane (See Photo 47). The stairways in the west tower are in good condition with some surface rusting and pitting. The platform at the top of the stair tower is cantilevered 15' from the support and is very unstable. A support angle, which was used to stabilize the platform, is not connected. Some walkway railings are not connected.

Photo 47: Ore Bridge Elevation

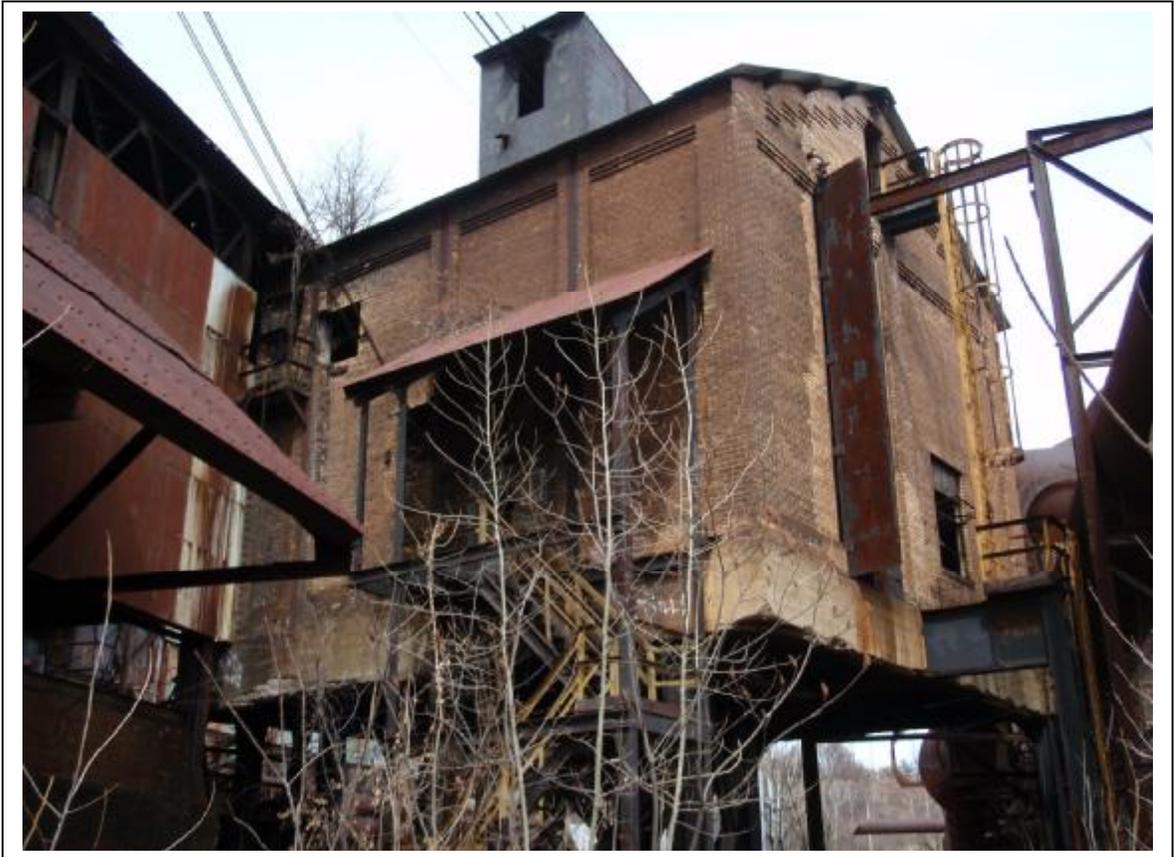
The south building's north wall has cracks in the brick (See Photos 49 and 50). It also has loose, cracked and delaminated concrete that is above the ground (i.e. overhead) that is a possible hazard. The stair up to the second level is missing two steps and is moderately to severely deteriorated.

Photo 49: Skip Hoist Motor Building for South Furnace typical exterior

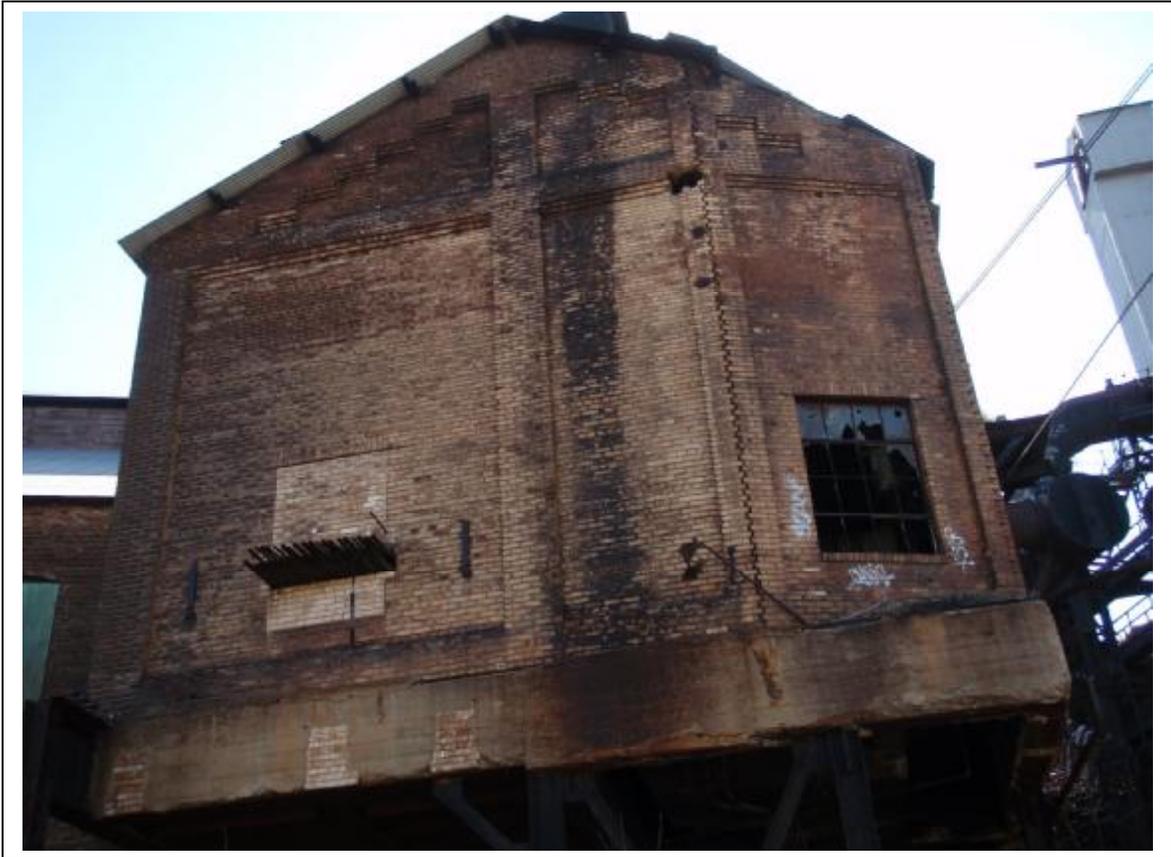
The two story buildings housed the motors which operated the skip hoists (See Photos 51 and 52). The inside of the buildings appear stable and the walkways are generally in good condition. Some of the railings on the second level of the north building need to be repaired. A stairway, landing and ladder along the outside south face of the north building are badly deteriorated with advanced section loss. A 30' long ladder along the interior NW face which accesses a platform at the top of the north building is not connected at the top and needs repaired. A column base at the NW corner of the north building made of brick is deteriorated and the base plate is not supported (undermined). The north wall of the north building is cracked (See Photo 53). The south wall of the north building has a 1/2" wide diagonal crack through the brick from the top of the door up to the roof.

Photo 51: Skip Hoist Motor Building for North Furnace typical exterior

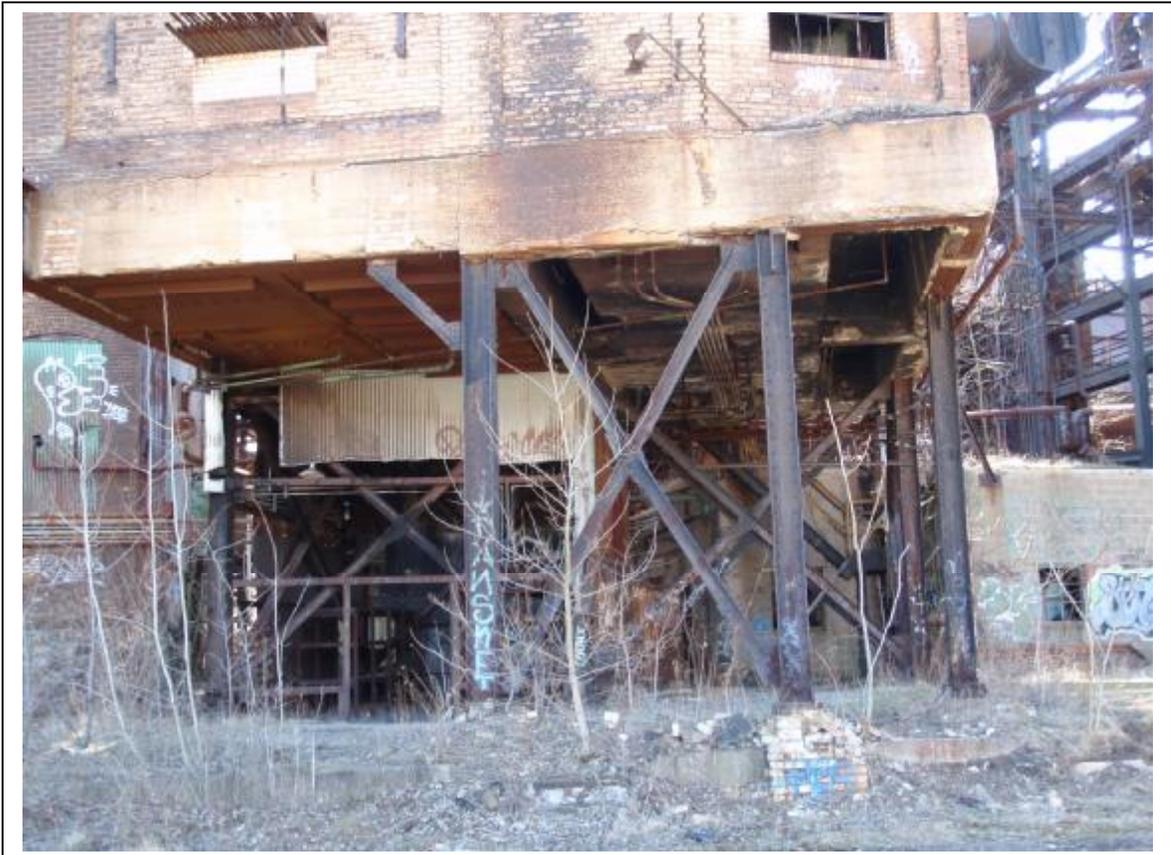
Photo 52: Skip Hoist Motor Building for North Furnace framing underneath it

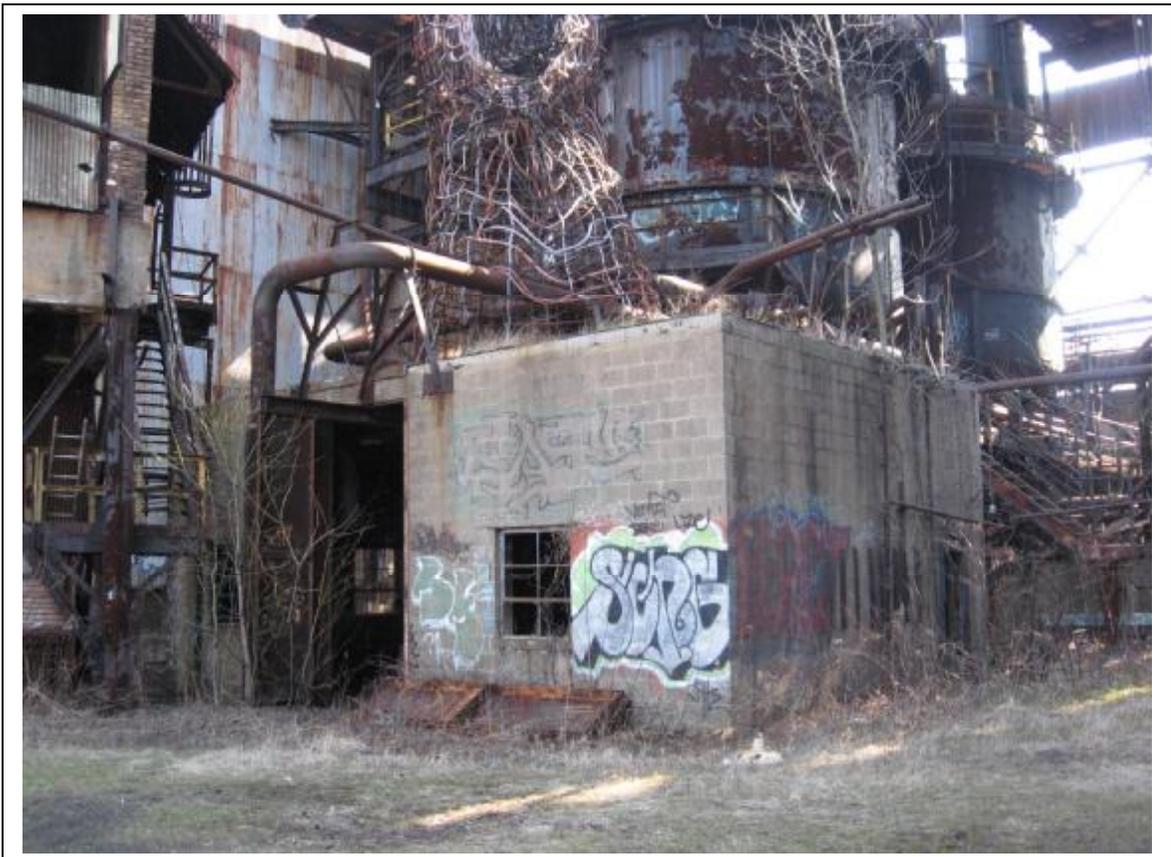
This small building sits at the SW corner of the motor building (See Photo 54). The building is single story with a below ground area. The below ground area is filled with water and therefore inaccessible (See Photo 56). The building roof is comprised of concrete panels which are collapsing at various locations (See Photo 55). A heater unit suspended from the ceiling is deteriorated and is in danger of collapse.

Photo 54: Masonry Building #1 Typical exterior

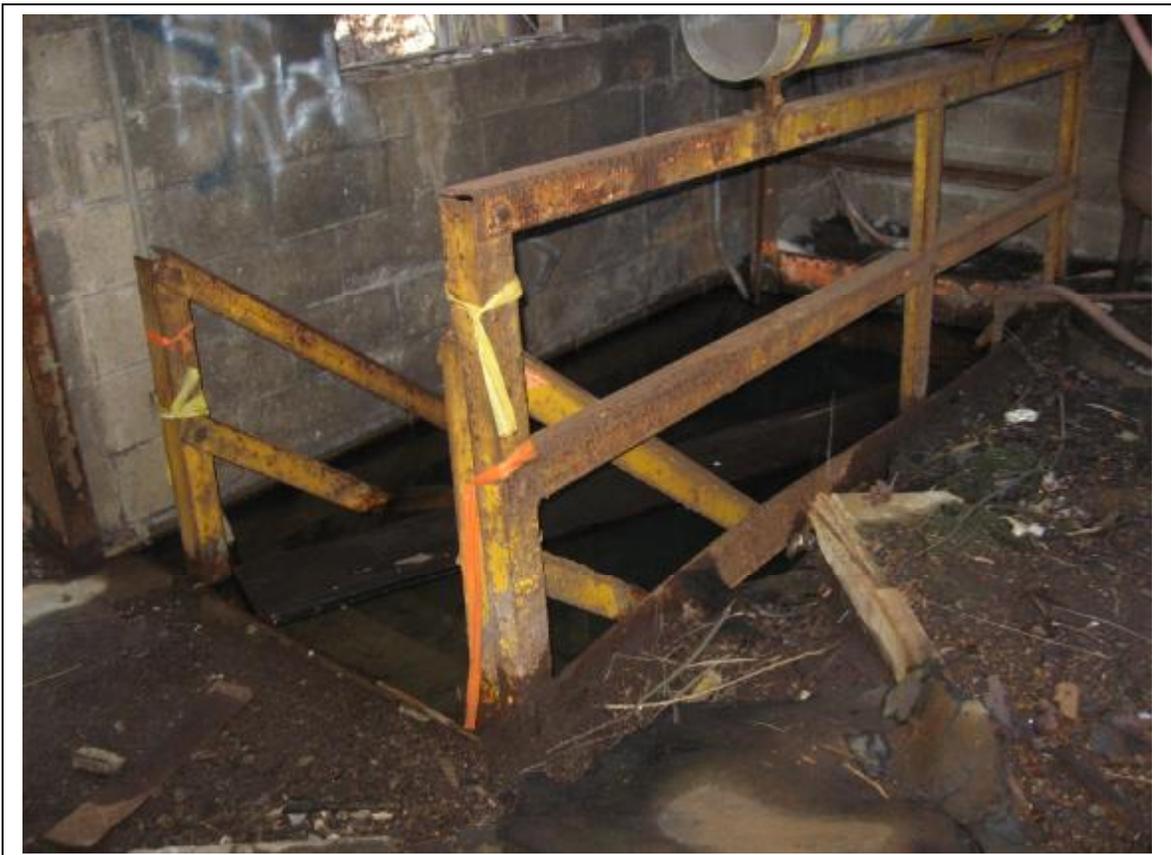
Photo 56: Masonry Building #1 basement filled with water and not inspected

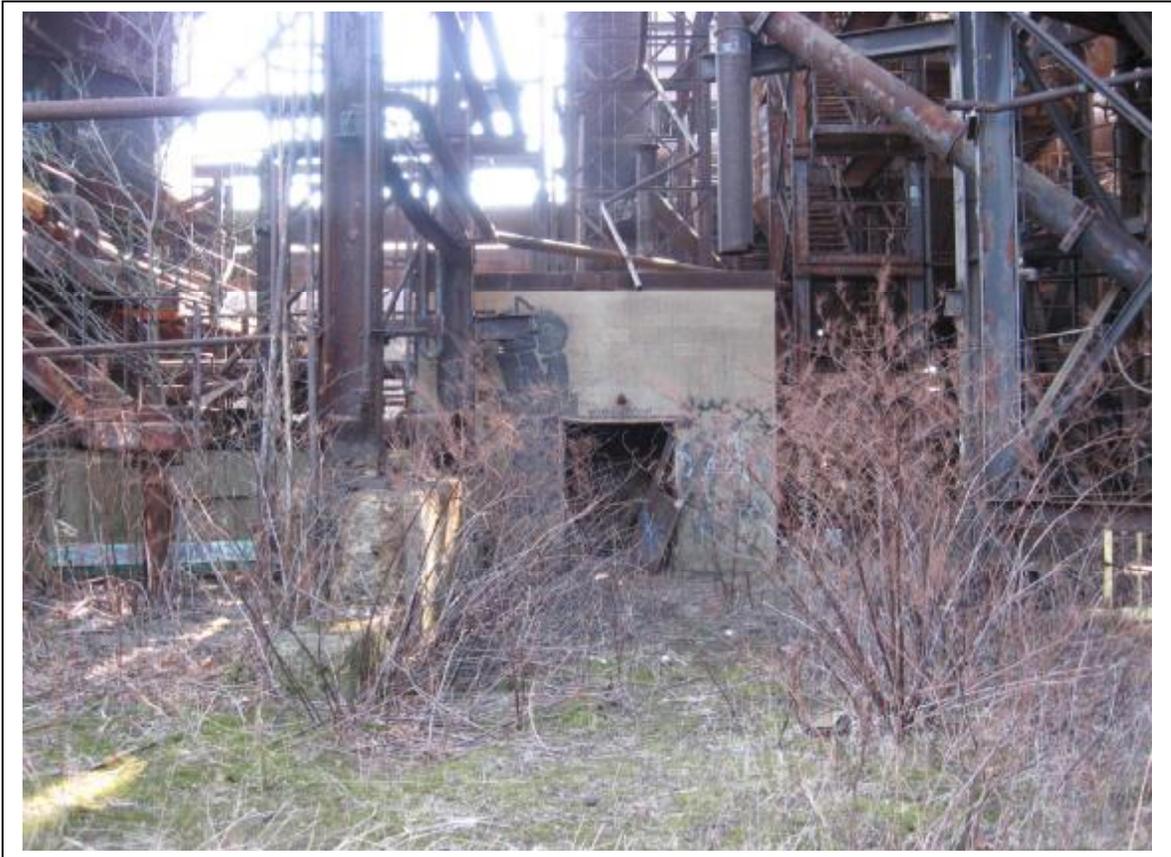
This small building sits between the two gas washers (See Photo 57). The basic structure is in fair condition with portions of the corrugated metal roof collapsing. The roof steel support beams are in good condition. The masonry walls are in good condition with some minor cracking.

Photo 57: Masonry Building #2 typical exterior
